NATIONAL  
TRUST  
FOR  
HISTORIC  
PRESERVATION®

# Repair or Replace Old Windows

**A Visual Look at the Impacts**

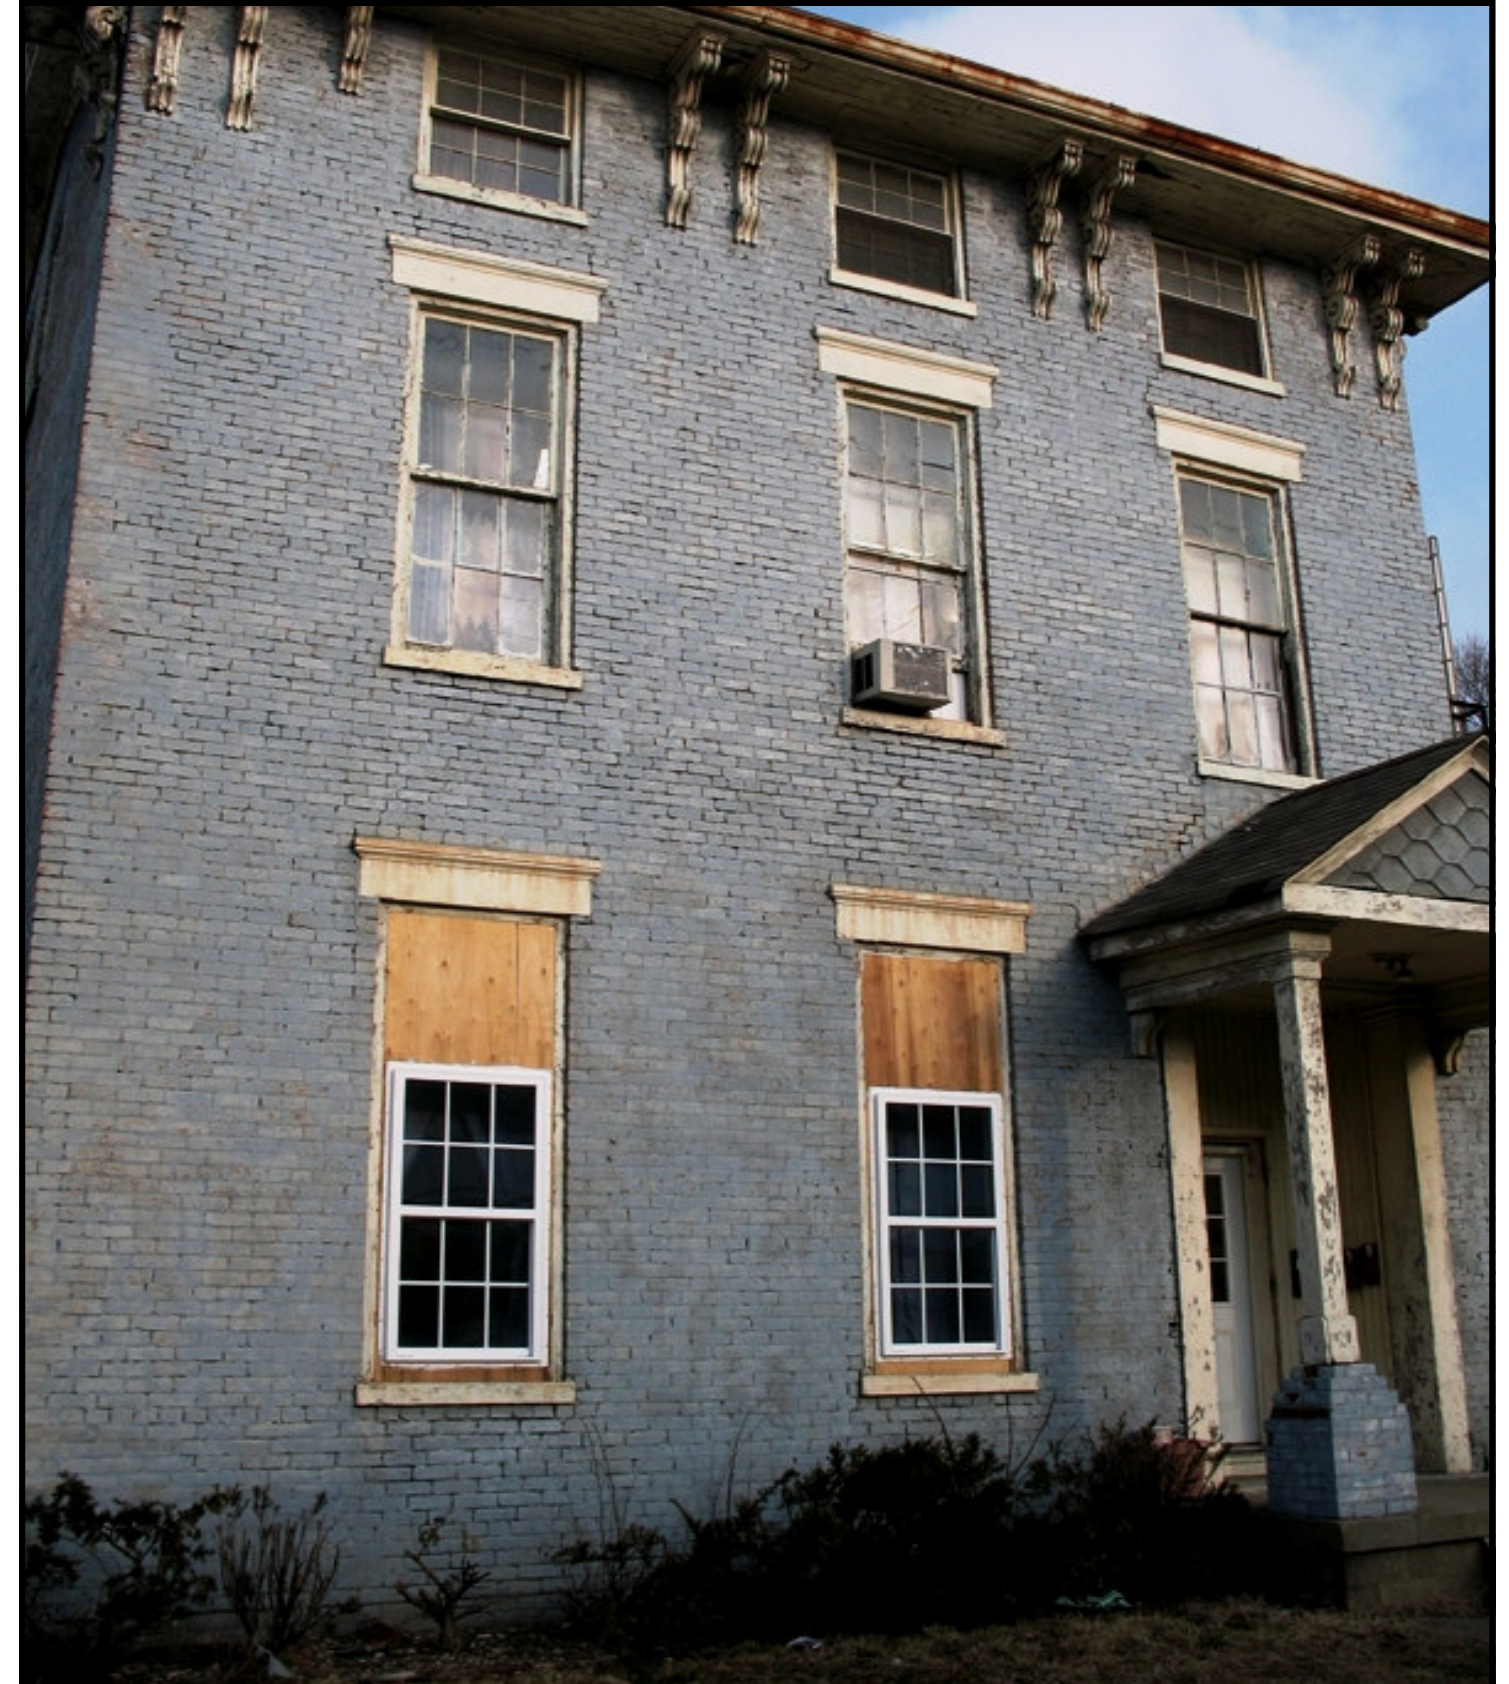
### 19th century Italianate style house Replacement windows do not match size, type or material

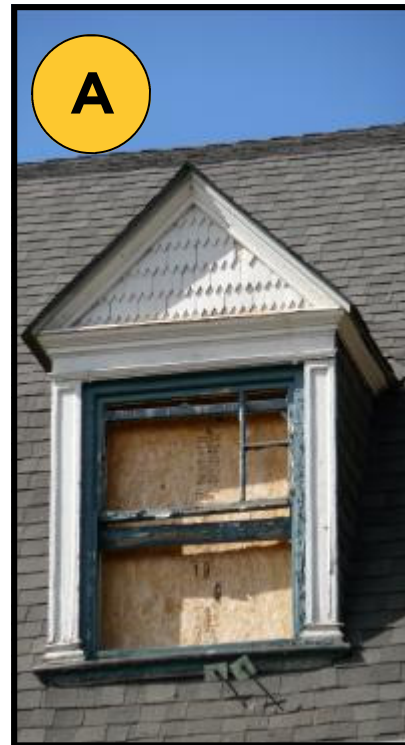
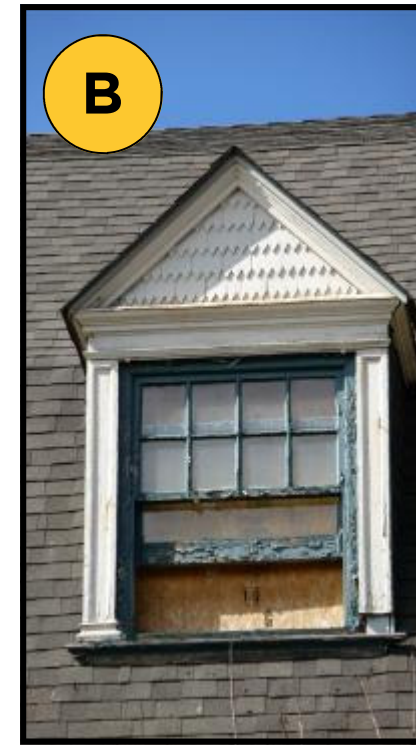
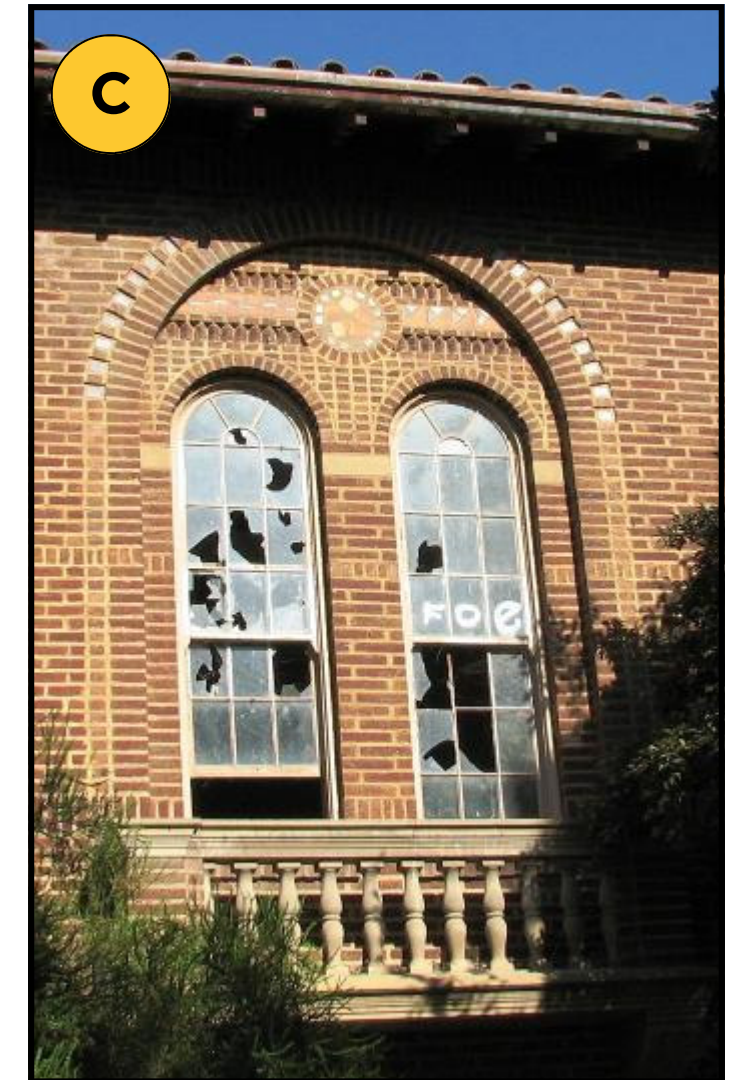
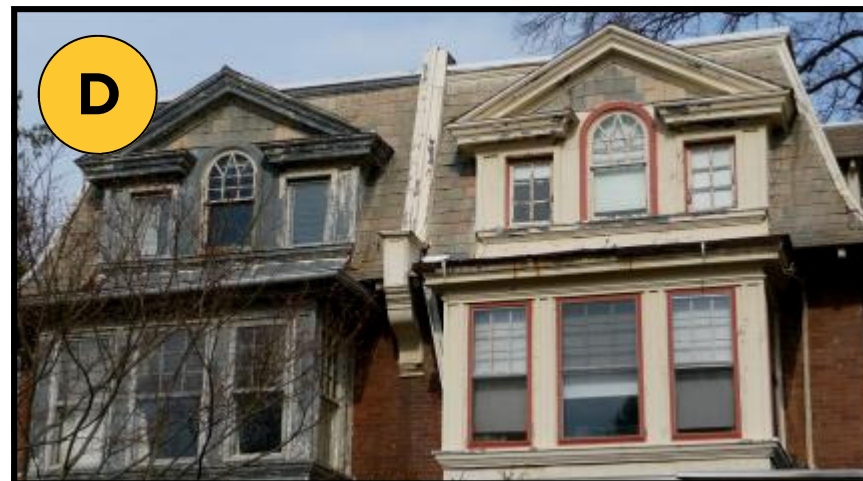
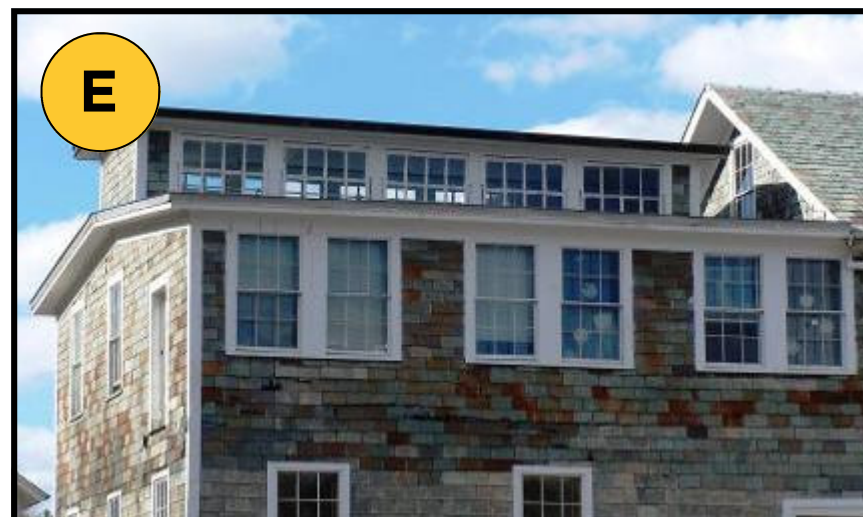
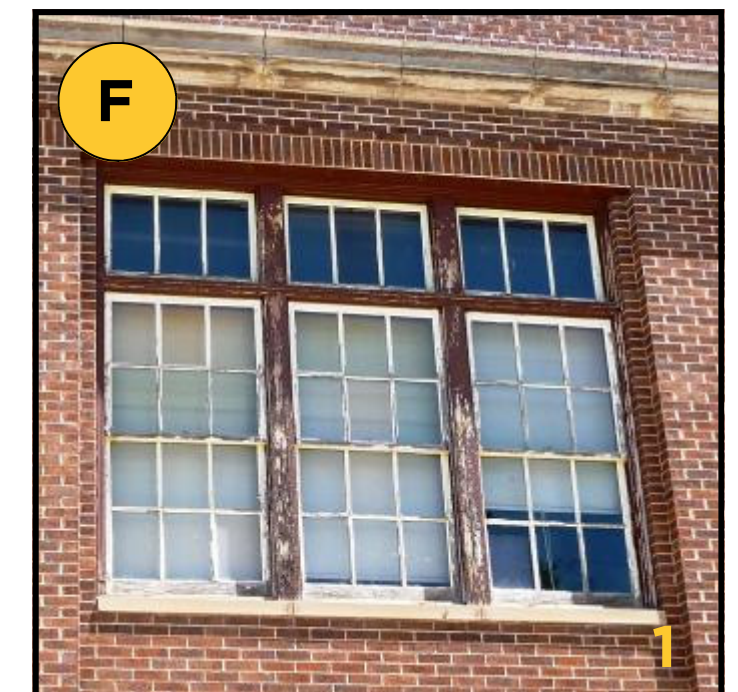
- A, B Two eight-over-eight double-hung sash dormer windows. Both are in disrepair; window A will need to be rebuilt or replaced to match window B.
- C Broken glass on these architecturally distinctive windows can be easily replaced and windows repaired.
- D A coat of paint and routine and preventive maintenance can restore windows to their original appearance.
- E Unique roof monitor with well-maintained and character defining six-over-six double-hung sash windows.
- F Group of six-over-six double-hung sash windows with transoms, only needing paint.

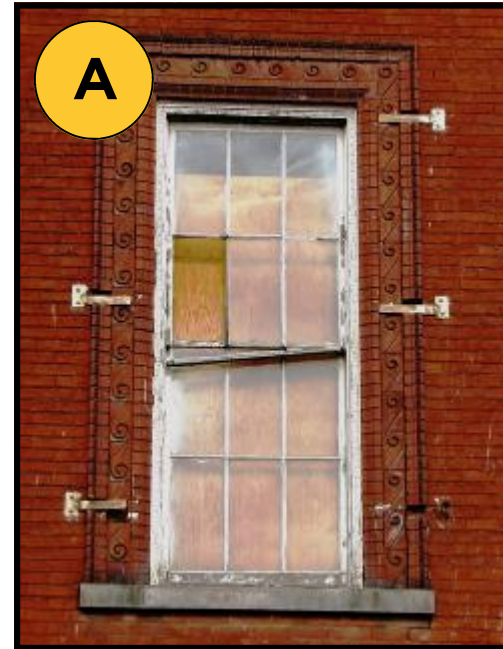
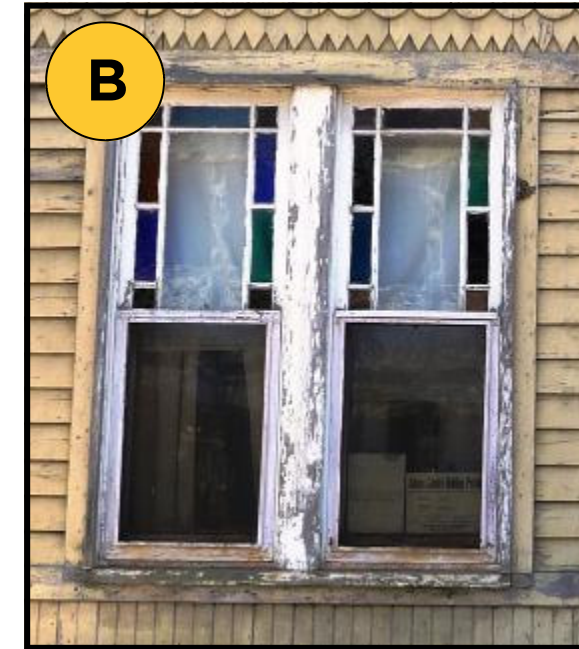
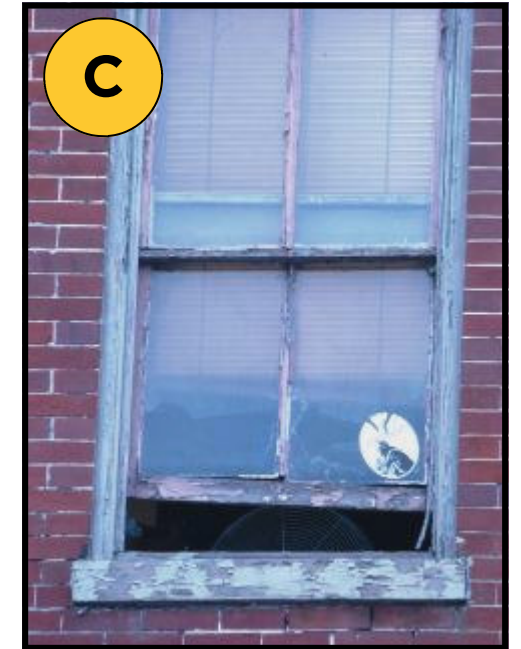
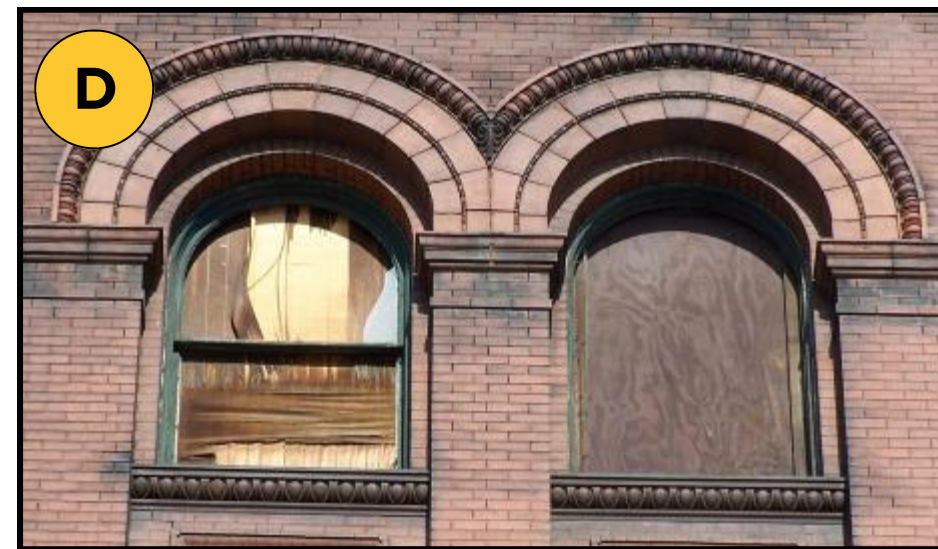
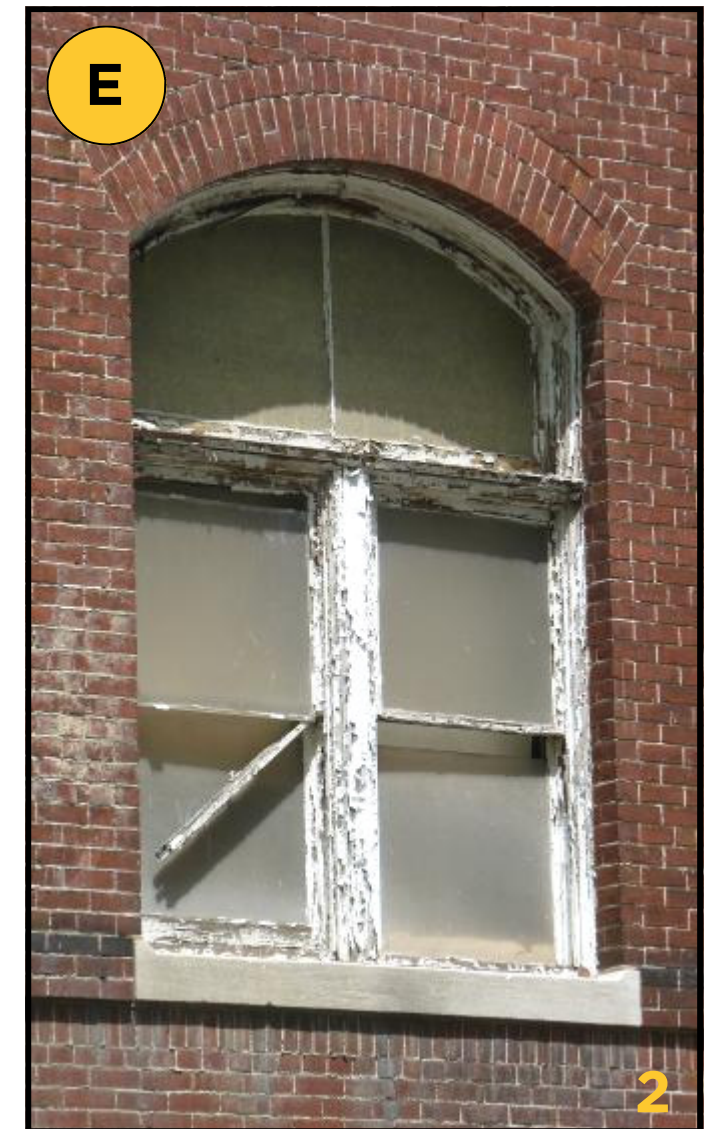
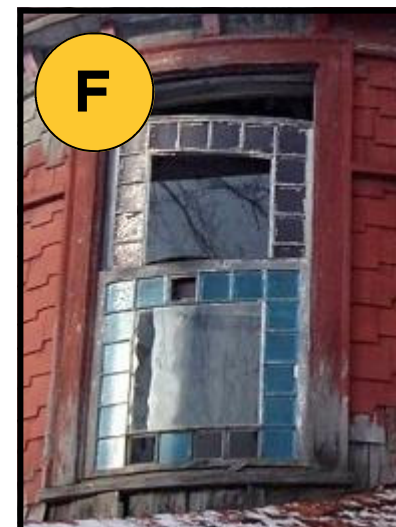
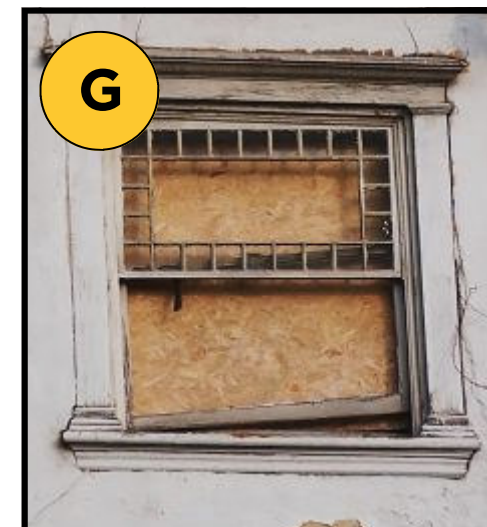
- A Six-over-six double-hung sash with loose meeting rail, missing glass — can be repaired.
- B Queen Anne windows needing paint, re-glazing — can be repaired.
- C Two-over-two double-hung sash with loose bottom rail, needing paint, re-glazing — can be repaired.
- D Arched double-hung sash windows missing glass and frames — replacement likely.
- E One-over-one double-hung sash windows and fixed transoms with detached meeting rail, needing paint and re-glazing — can be repaired.
- F Queen Anne window in poor condition, detached from frame and missing glass — borderline, requiring extensive repairs.
- G Queen Anne window missing glass and subject to structural settling of the building — borderline, requiring extensive repairs.

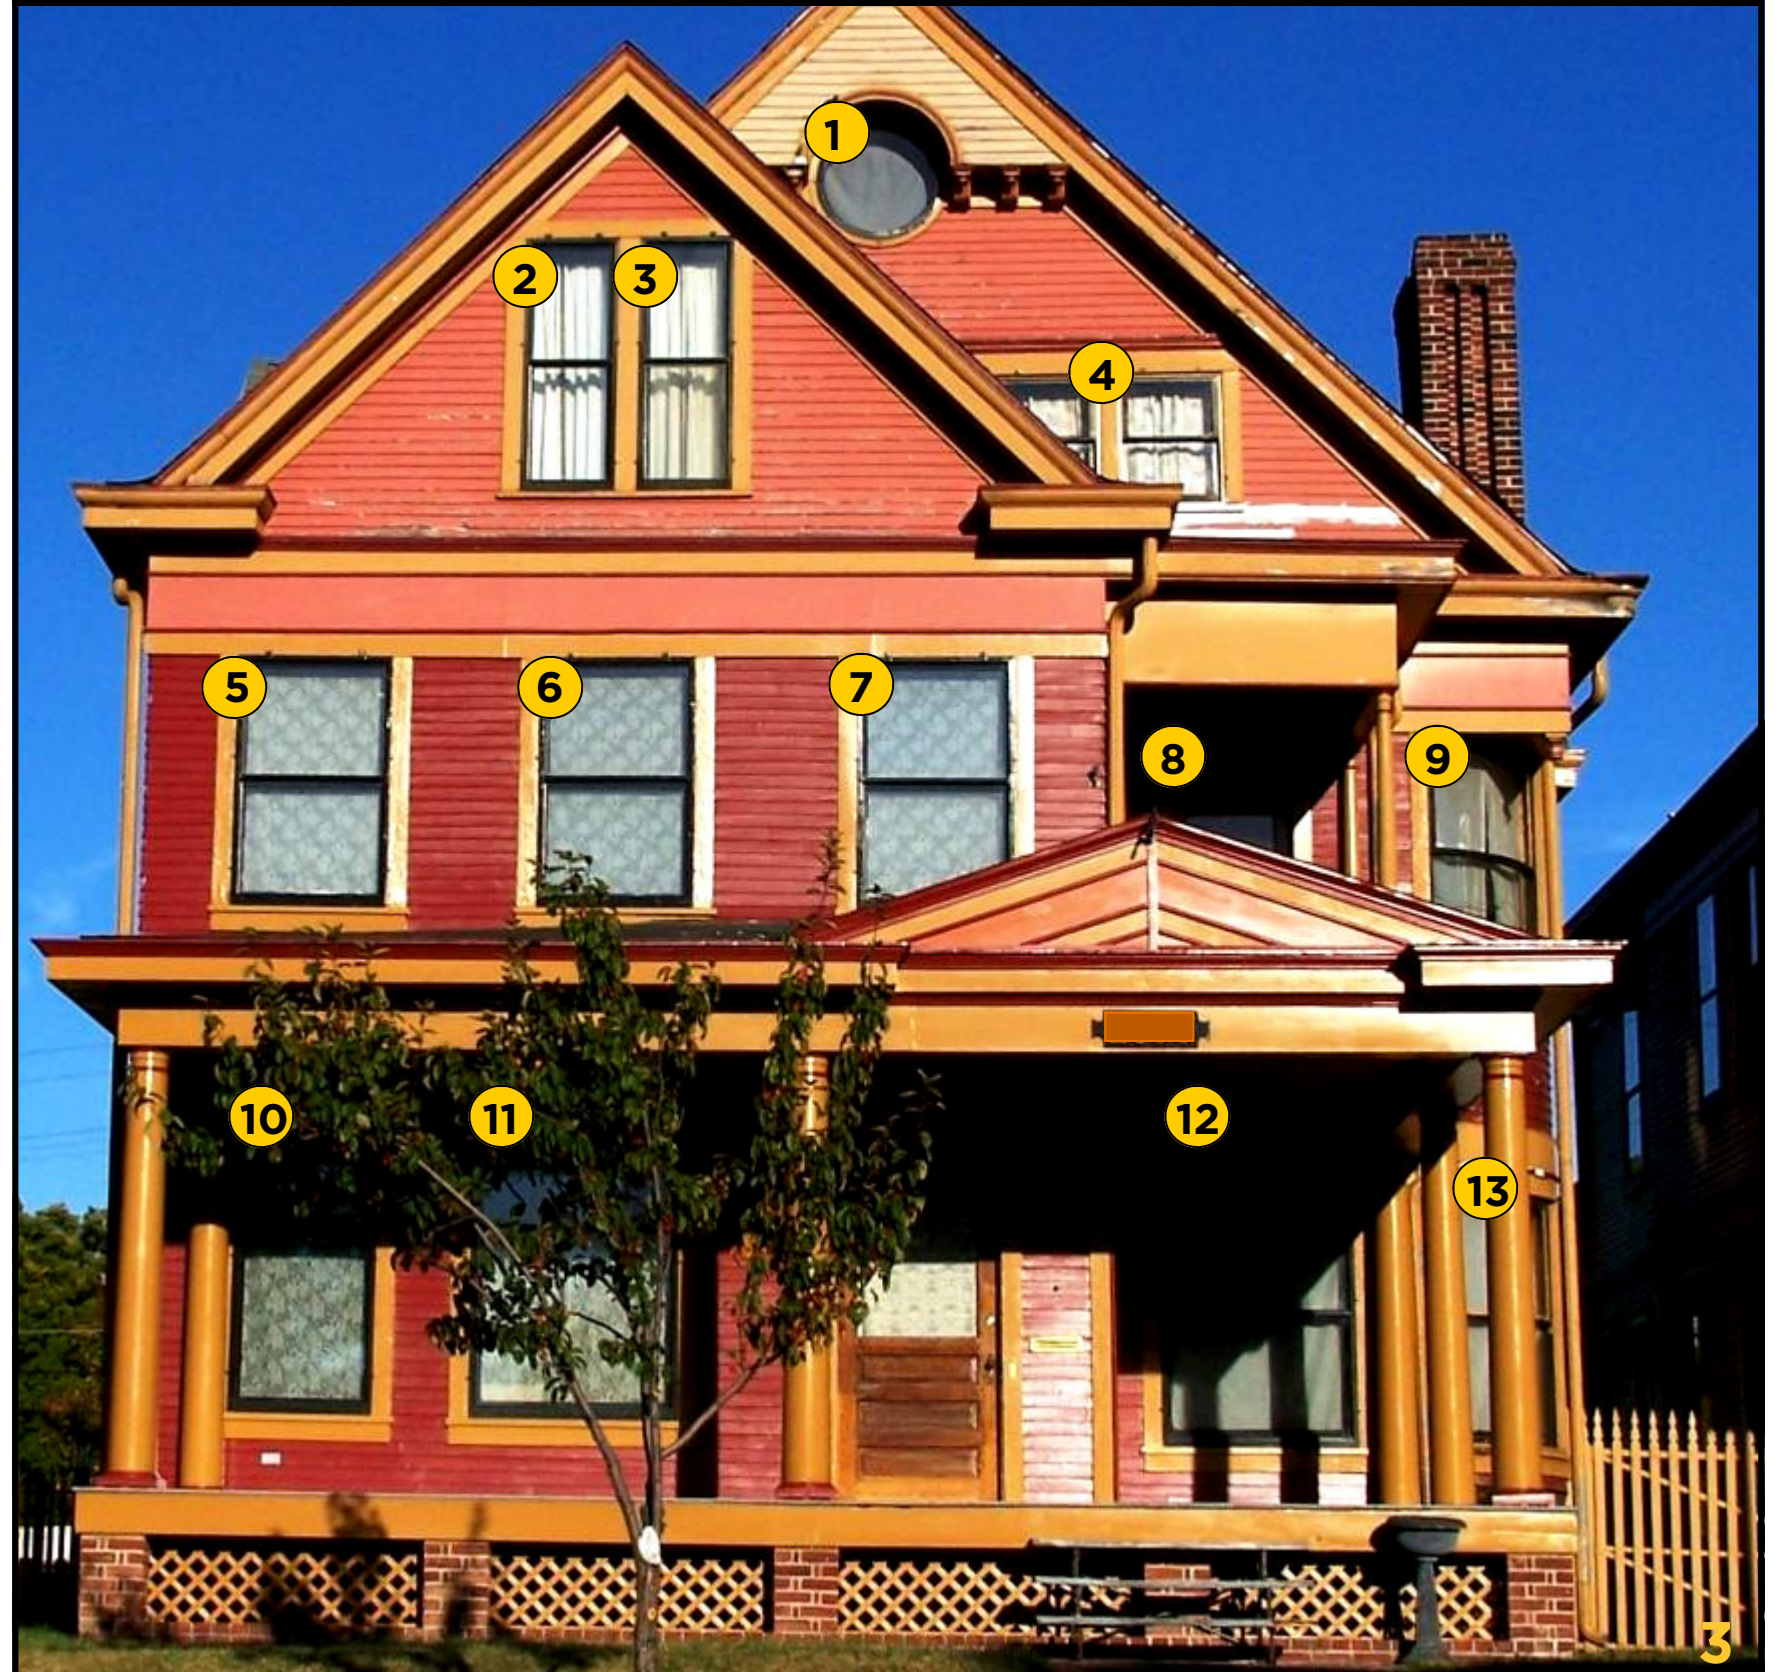
1890s Queen Anne style house  
Original one-over-one double-hung sash windows with storm windows

- 13 windows on the front of the house (in total 35)
- \$500-1,000 for each replacement window unit
- Total costs for new windows: \$17,500–35,000
- Average savings gained from replacement windows (in comparison to similar, restored windows with storms): \$25.00–50.00 per month
- The payback will take about 60 years

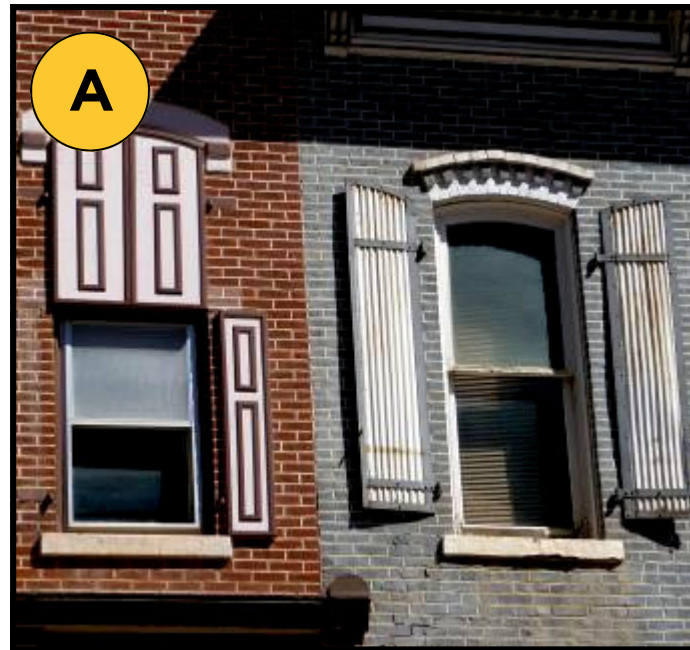
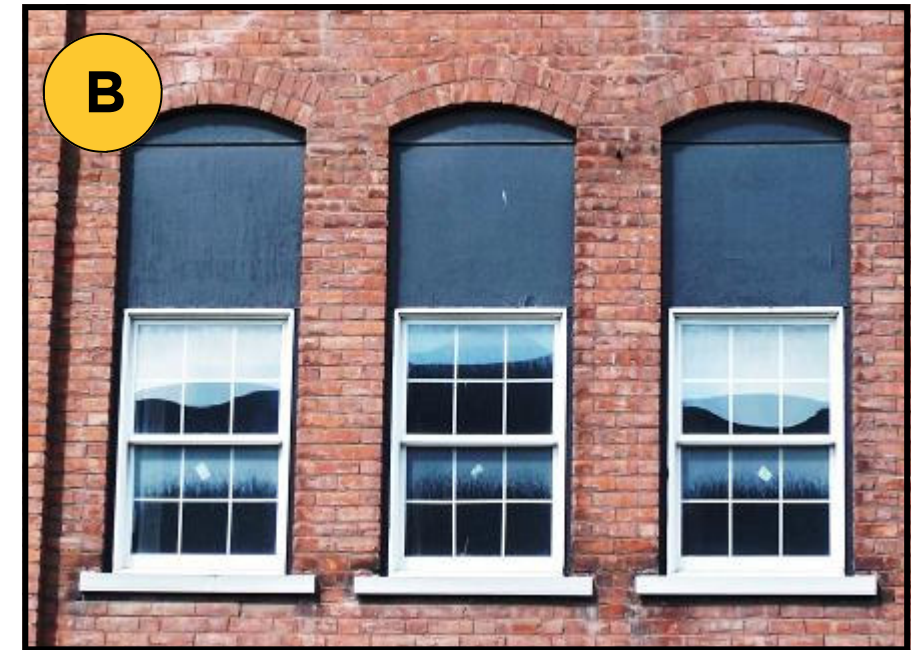
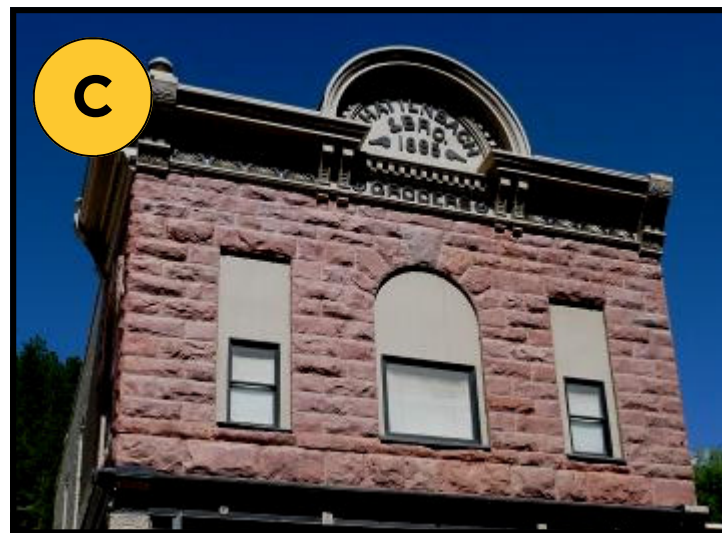
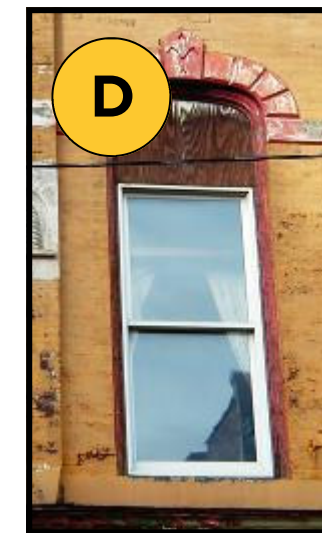
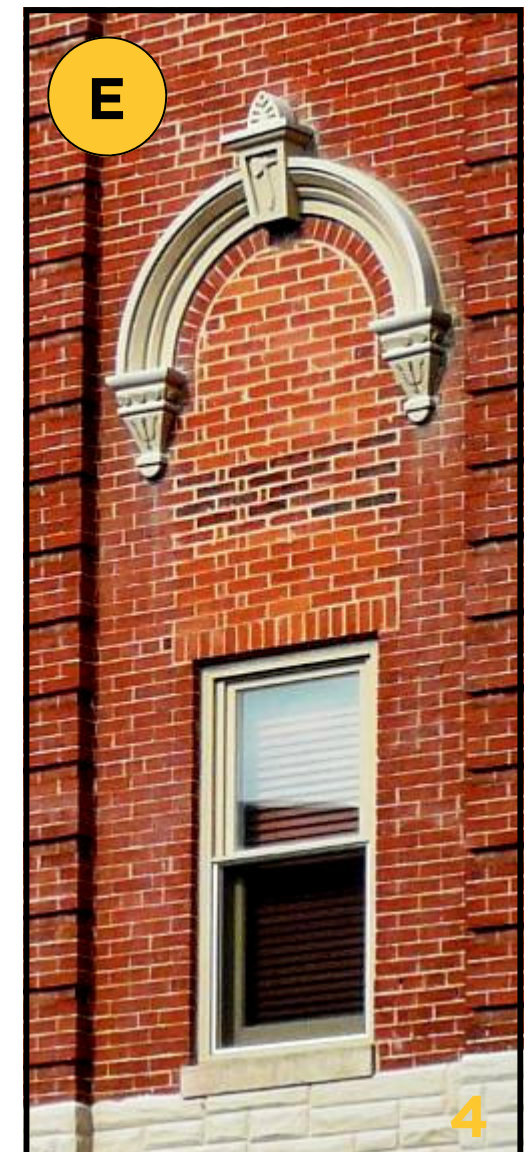
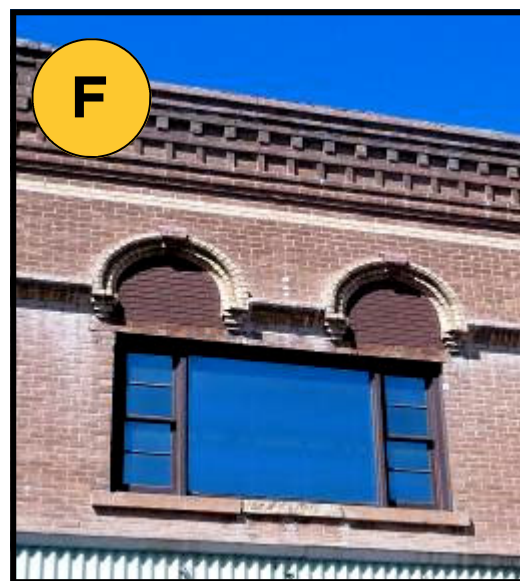
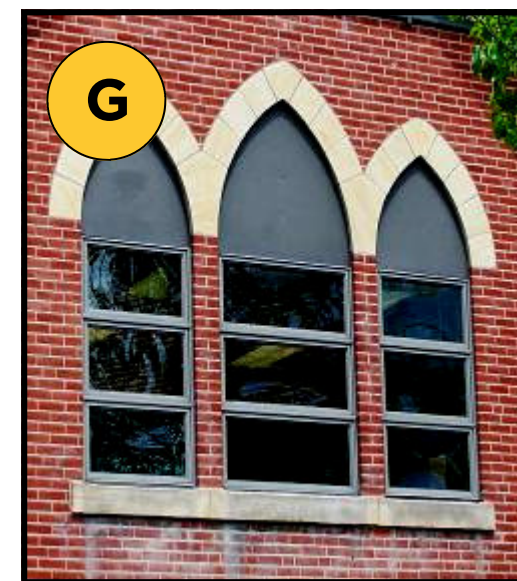
- A Italianate style row houses, side by side. Building to the right retains original arched one-over-one double-hung sash windows. Building to the left has smaller replacement windows and in-fill panels installed in the original opening.

- B Industrial building converted for housing with reduced windows and in-fill openings.
- C Main Street commercial building with upper floor windows removed, openings reduced down and much smaller replacement windows that do not match.

- D A stock, smaller window unit was used to replace a larger double-hung sash window.
- E Brick was used to in-fill the original opening of the round-arched window.

- F Two round arched windows were removed and replaced by one larger picture window, completely different in design and period to the historic Main Street building.

- G Three vertically-oriented Gothic style windows were reduced and replaced by horizontally-oriented hopper type windows.

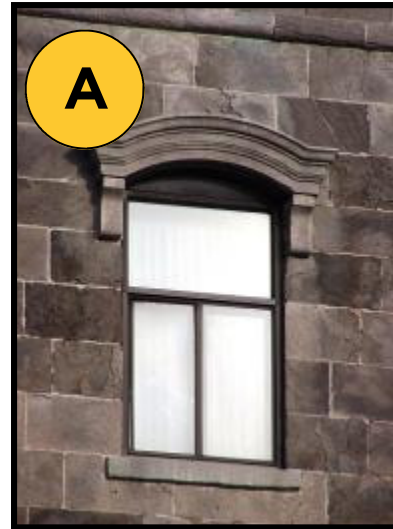
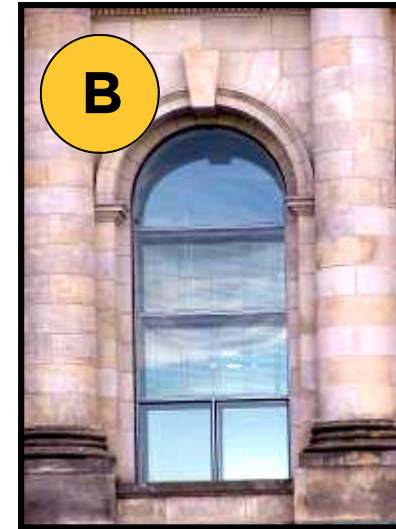
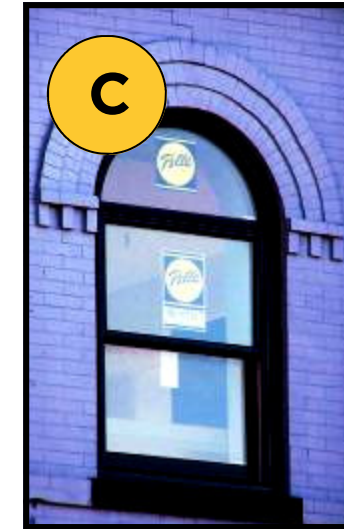
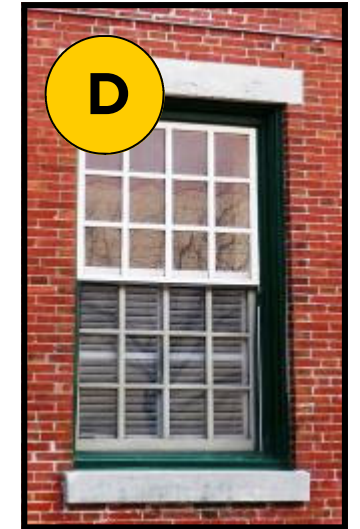
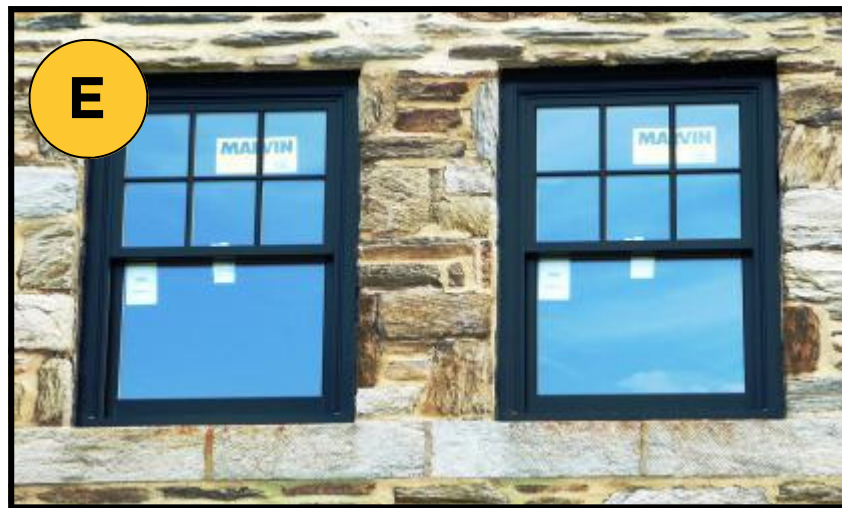
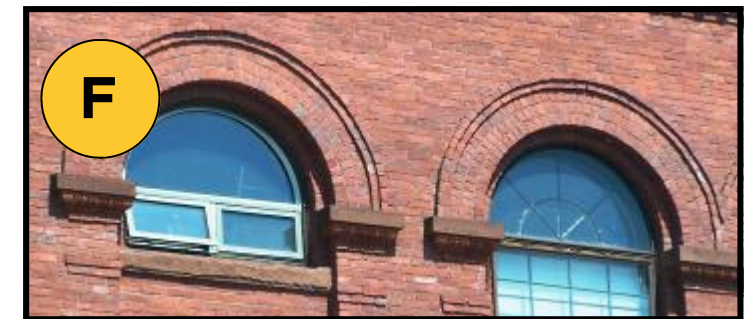
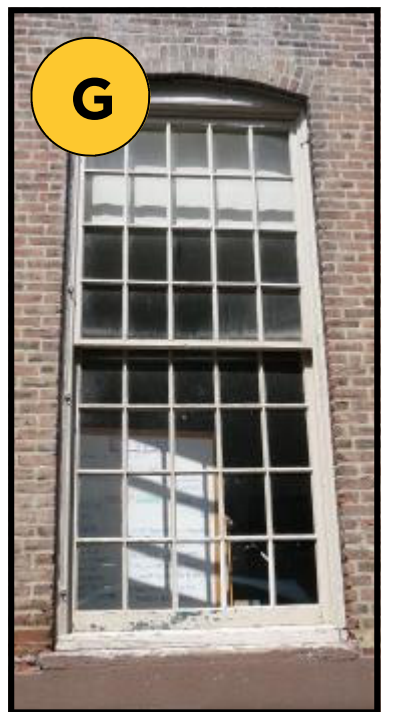
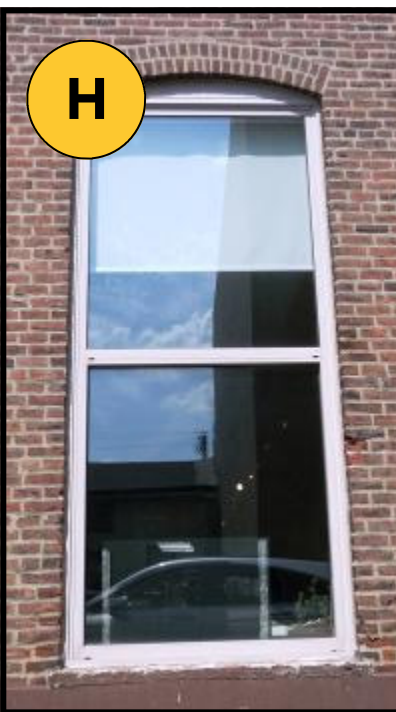
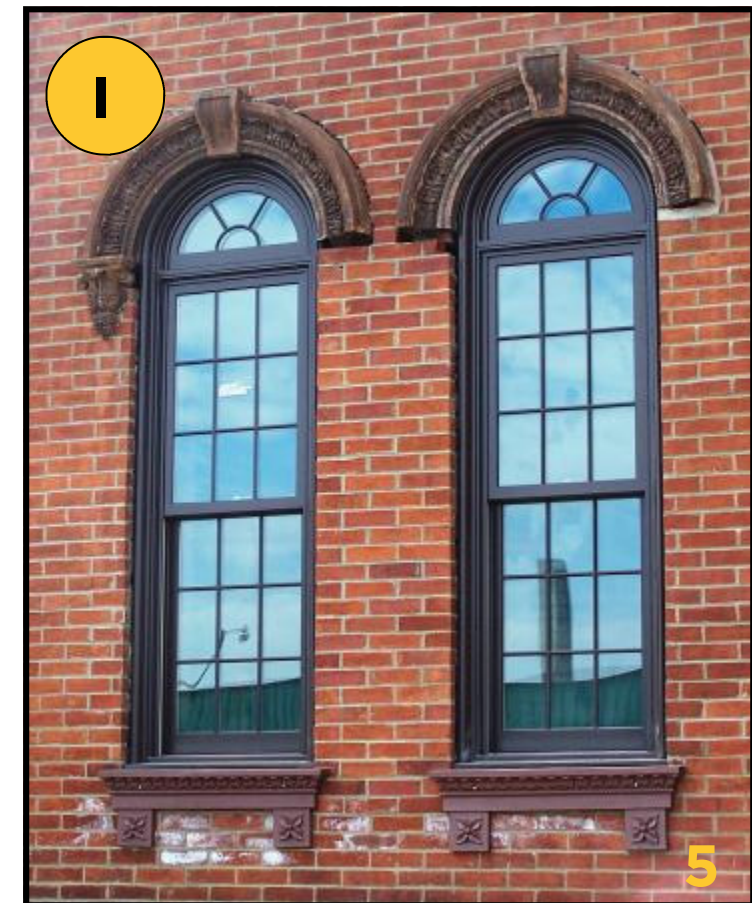
- A Replacing an original double-hung sash window with a casement and fixed transom dramatically changes the look and architectural character of this historic building.

- B Modern interpretation of an arched window alters the pattern and overall design on this monumental civic building. If original windows are no longer intact, this approach may be acceptable as windows clearly reflect their own era.

- C Replacing a round arched double-hung sash window is a one-over-one double-hung sash with fixed transom. This illustrates using stock windows to fit an opening that often requires a custom or more costly replacement window.

- D The thickness of muntins as well as their profile can make a difference. This window is not a true divided-light design, instead featuring applied, flat muntins.

- E New windows will often require 'building out' and enlarging the casing and surround to accommodate a stock replacement unit, effectively reducing the size of the window in comparison to the originals.

- F The introduction of a hopper window completely alters the look of this window.
- G, H Window G features the original twenty-over-twenty double-hung sash window. The replacement, window H, is a fixed one-over-one unit. The design, profile and depth are altered in the process.

- I New windows attempt to replicate originals, though the casing and surround is wider and the fixed fanlight does not match originals.

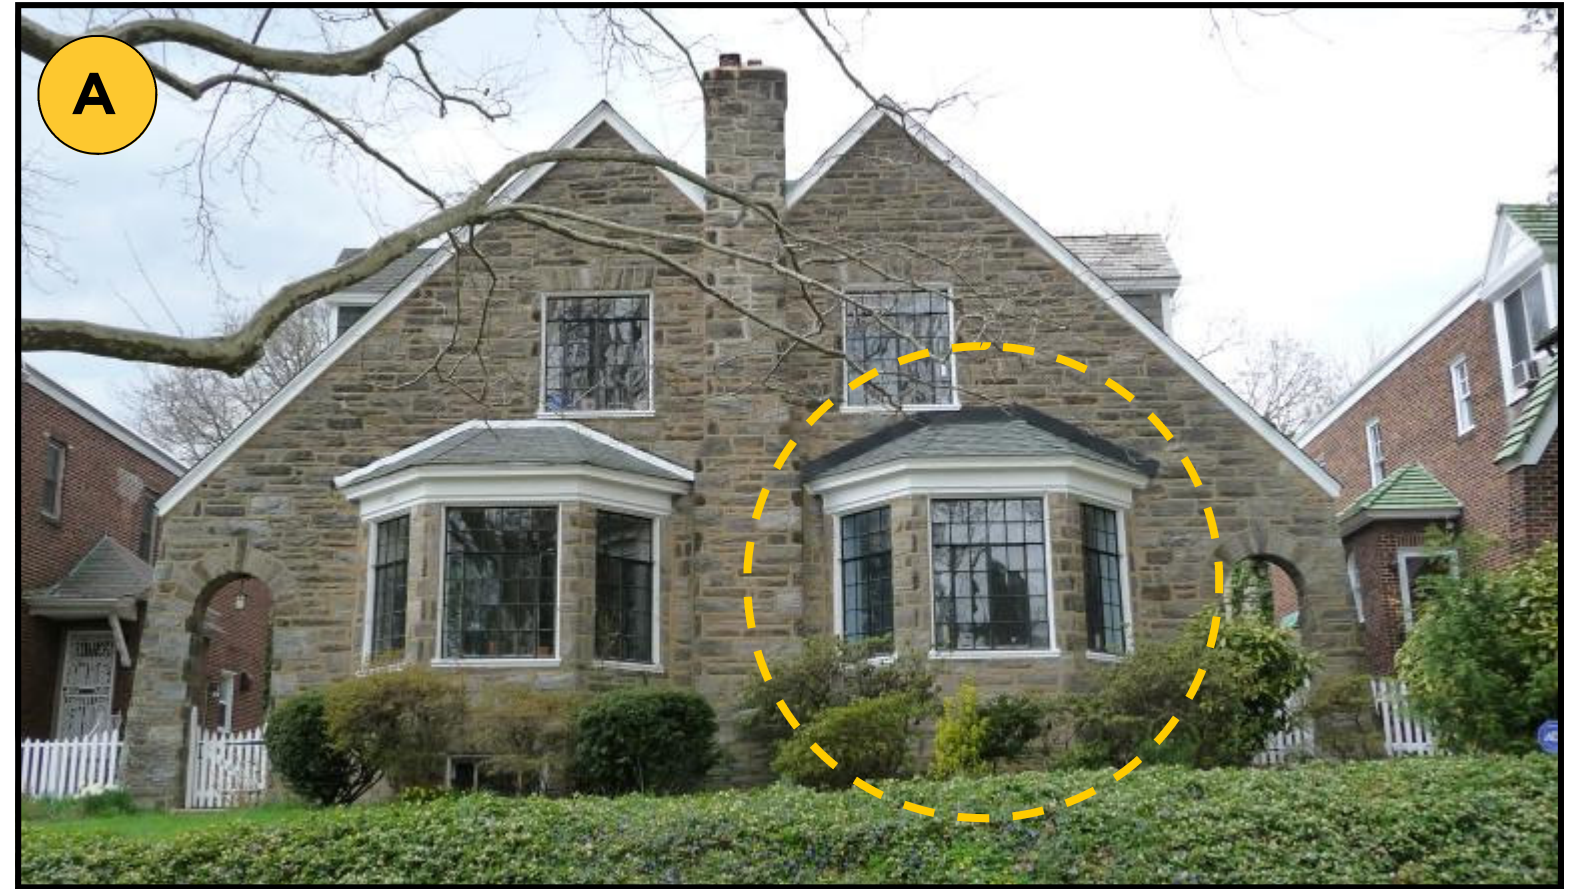
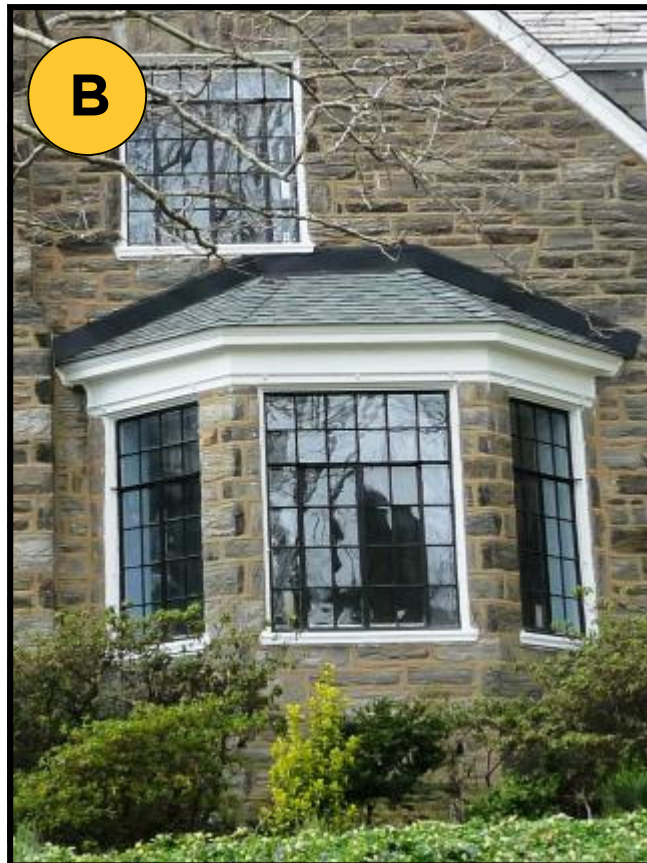
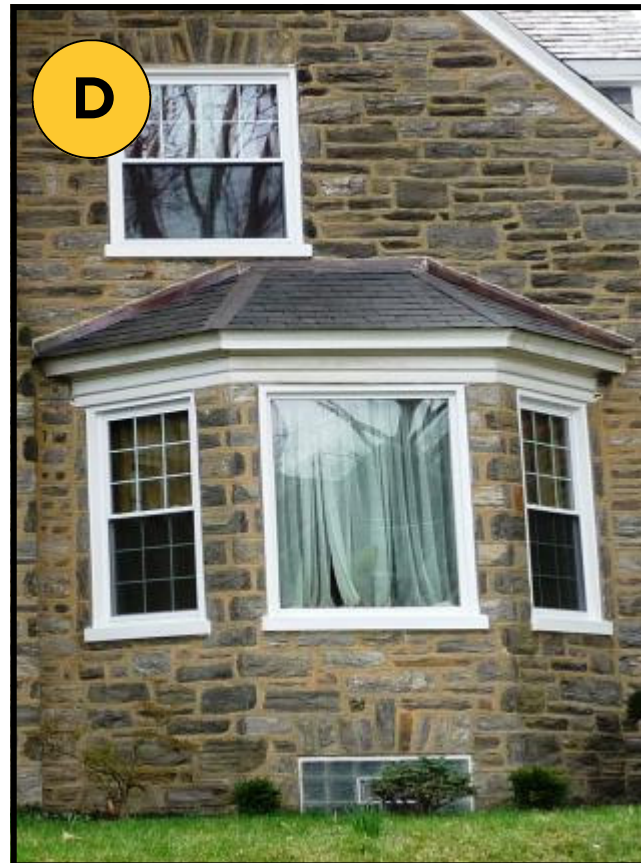
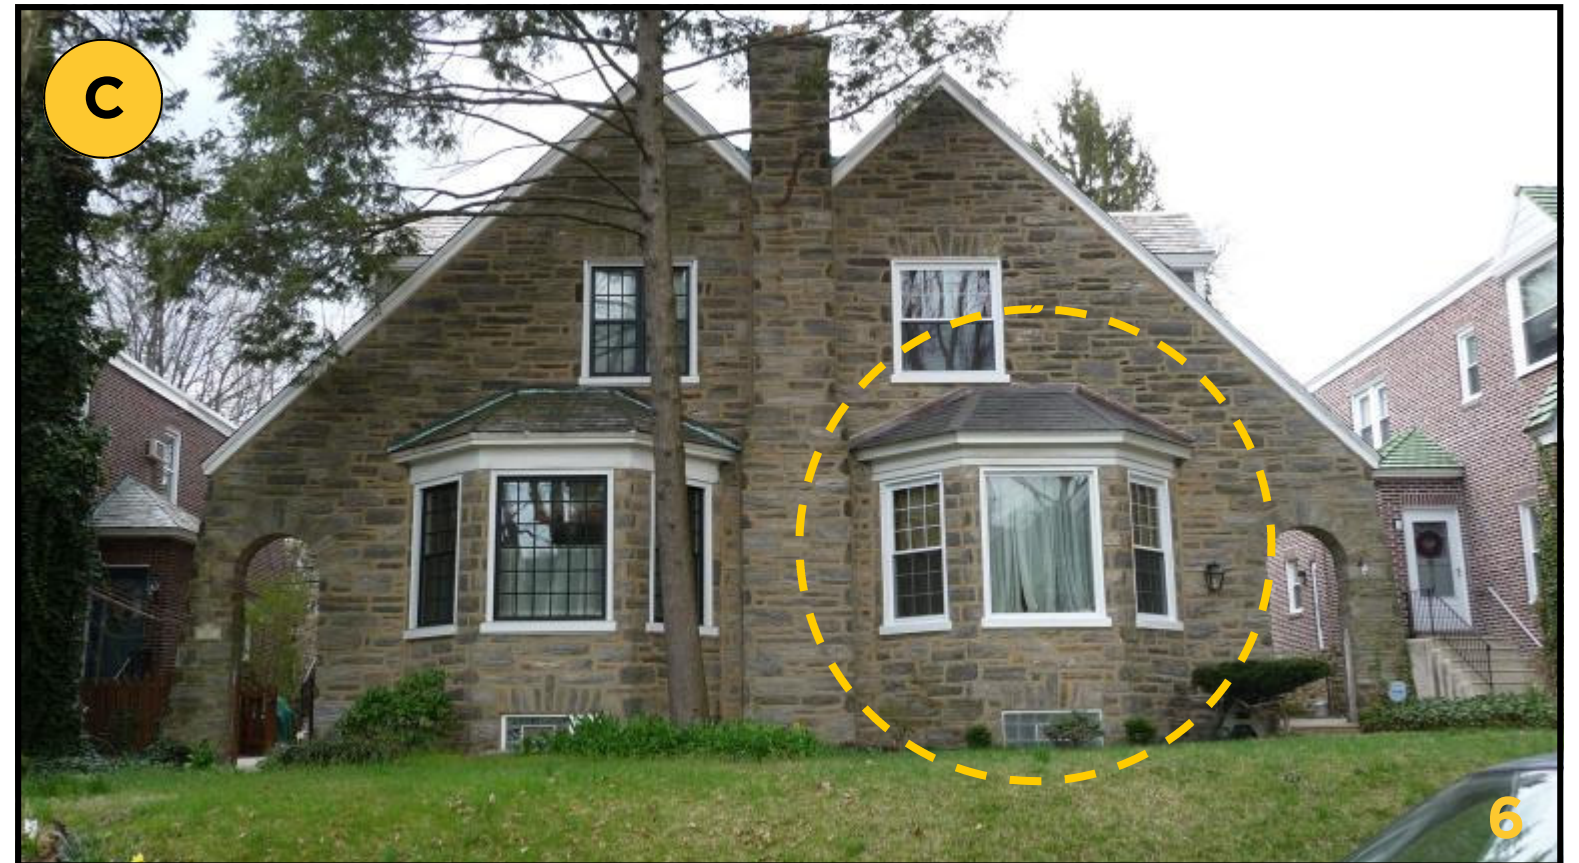
- A, B Both sides of this duplex feature original rolled steel casement windows with interior storm window inserts.
- C, D Both sides of this duplex have replacement windows. The one to the left more closely mimics the lines and details of the original steel casements, though the new windows are a mixture of fixed and double-hung sash units and the proportions are not an exact match. The unit to the right also features fixed and double-hung sash replacement windows. In this case, the result is less successful with white vinyl casing and a central picture window missing any muntin pattern.
