NATIONAL  
TRUST  
FOR  
HISTORIC  
PRESERVATION®

# Repair or Replace Old Windows

**A Visual Look at the Impacts**

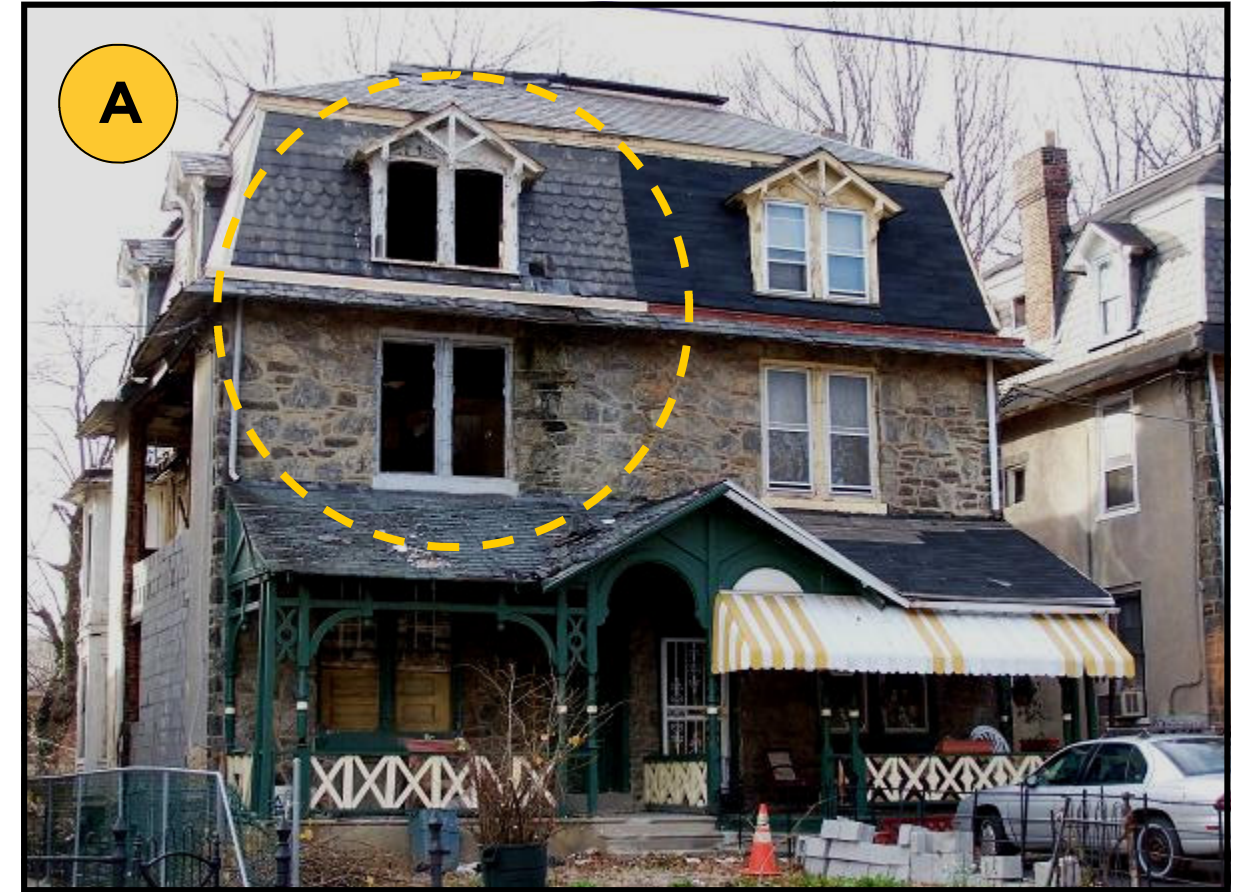
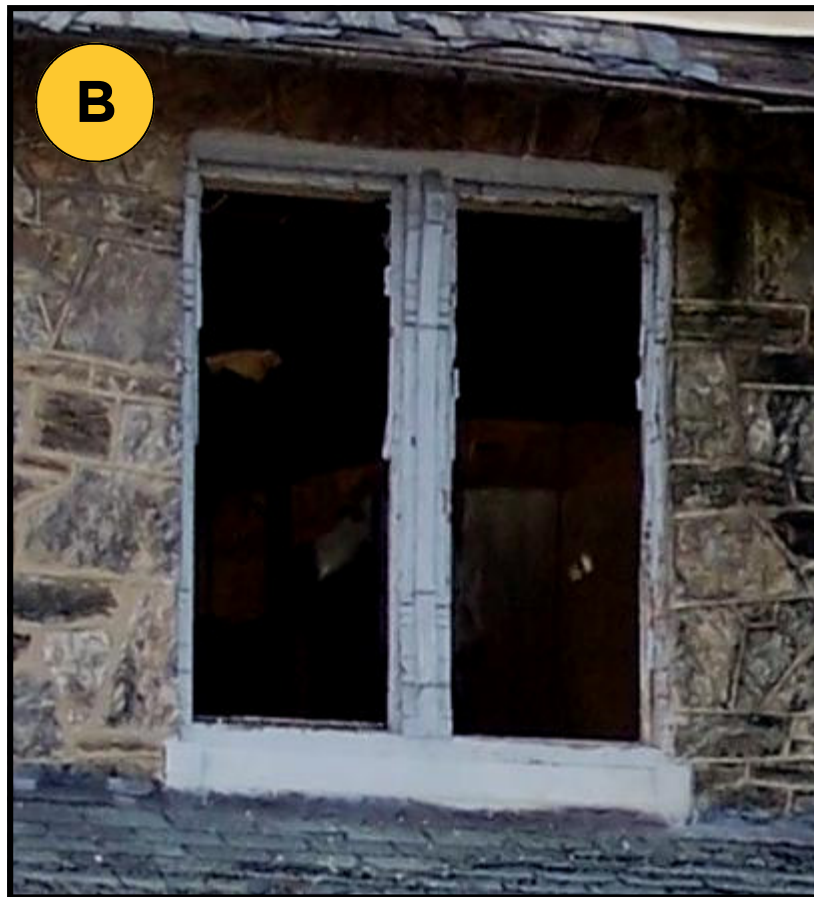
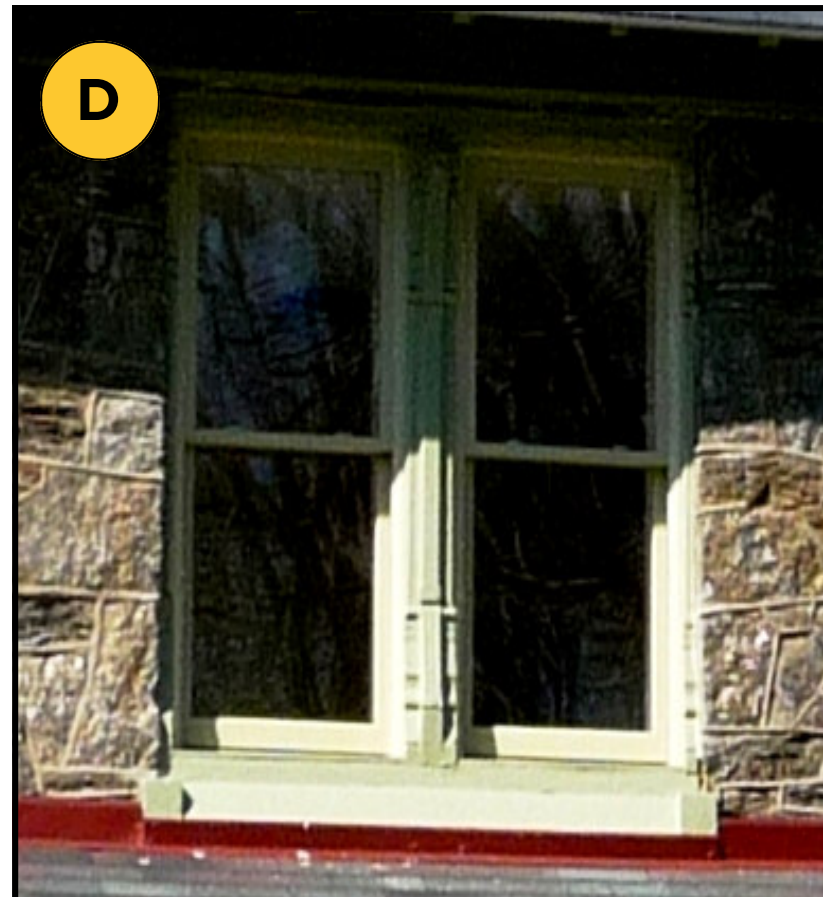
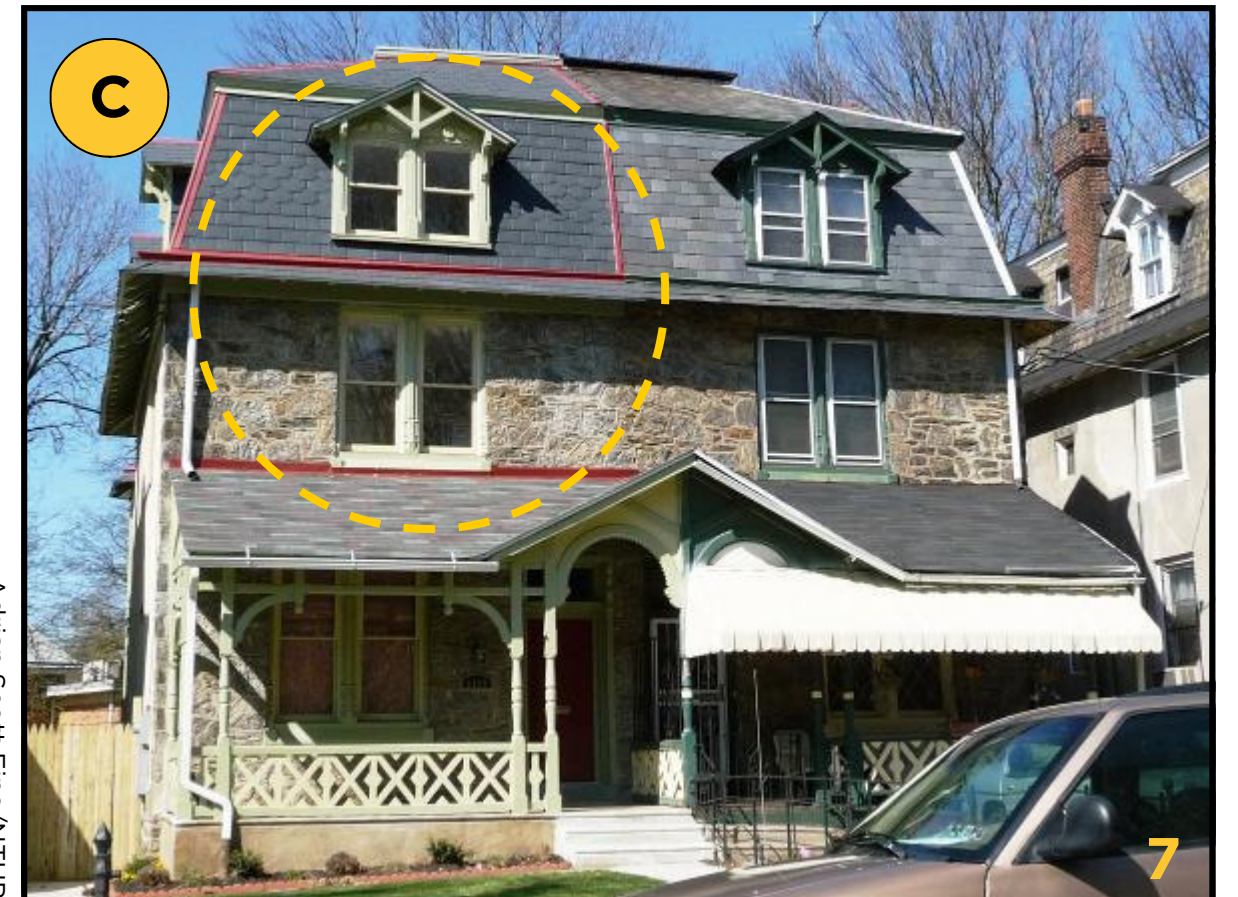
- A, B Original windows are missing but decorative casings and openings remain.
- C, D As part of the rehabilitation project, new wood double-hung sash windows were chosen to fit the original openings and the decorative casings were repaired and retained. New windows replicate the originals in terms of size, type, proportion and materials.

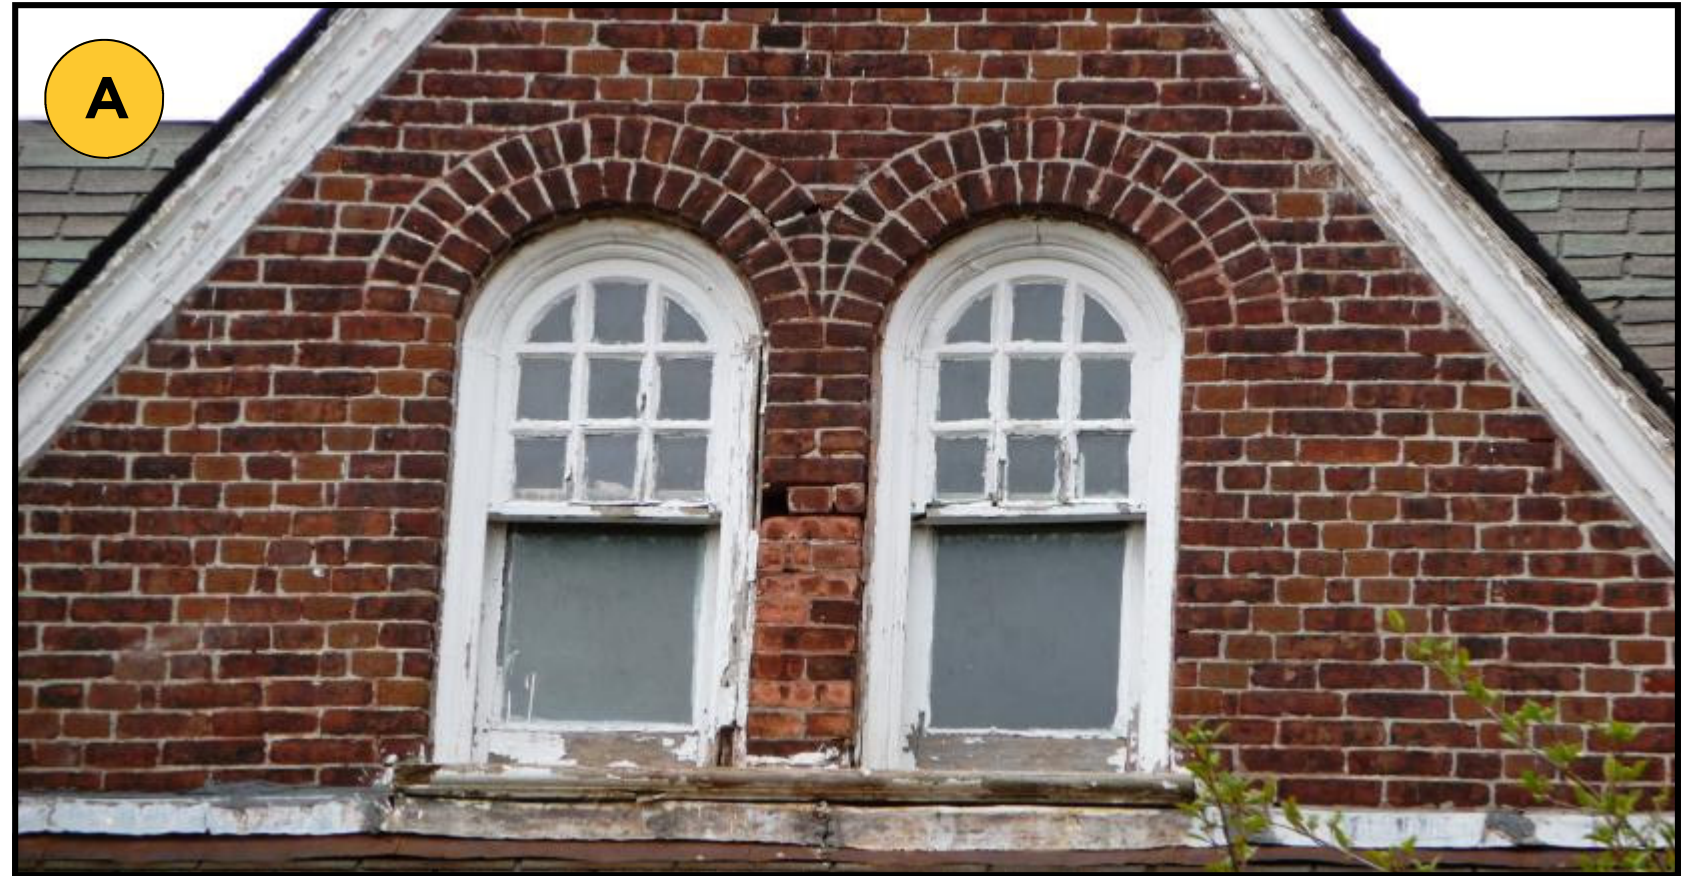
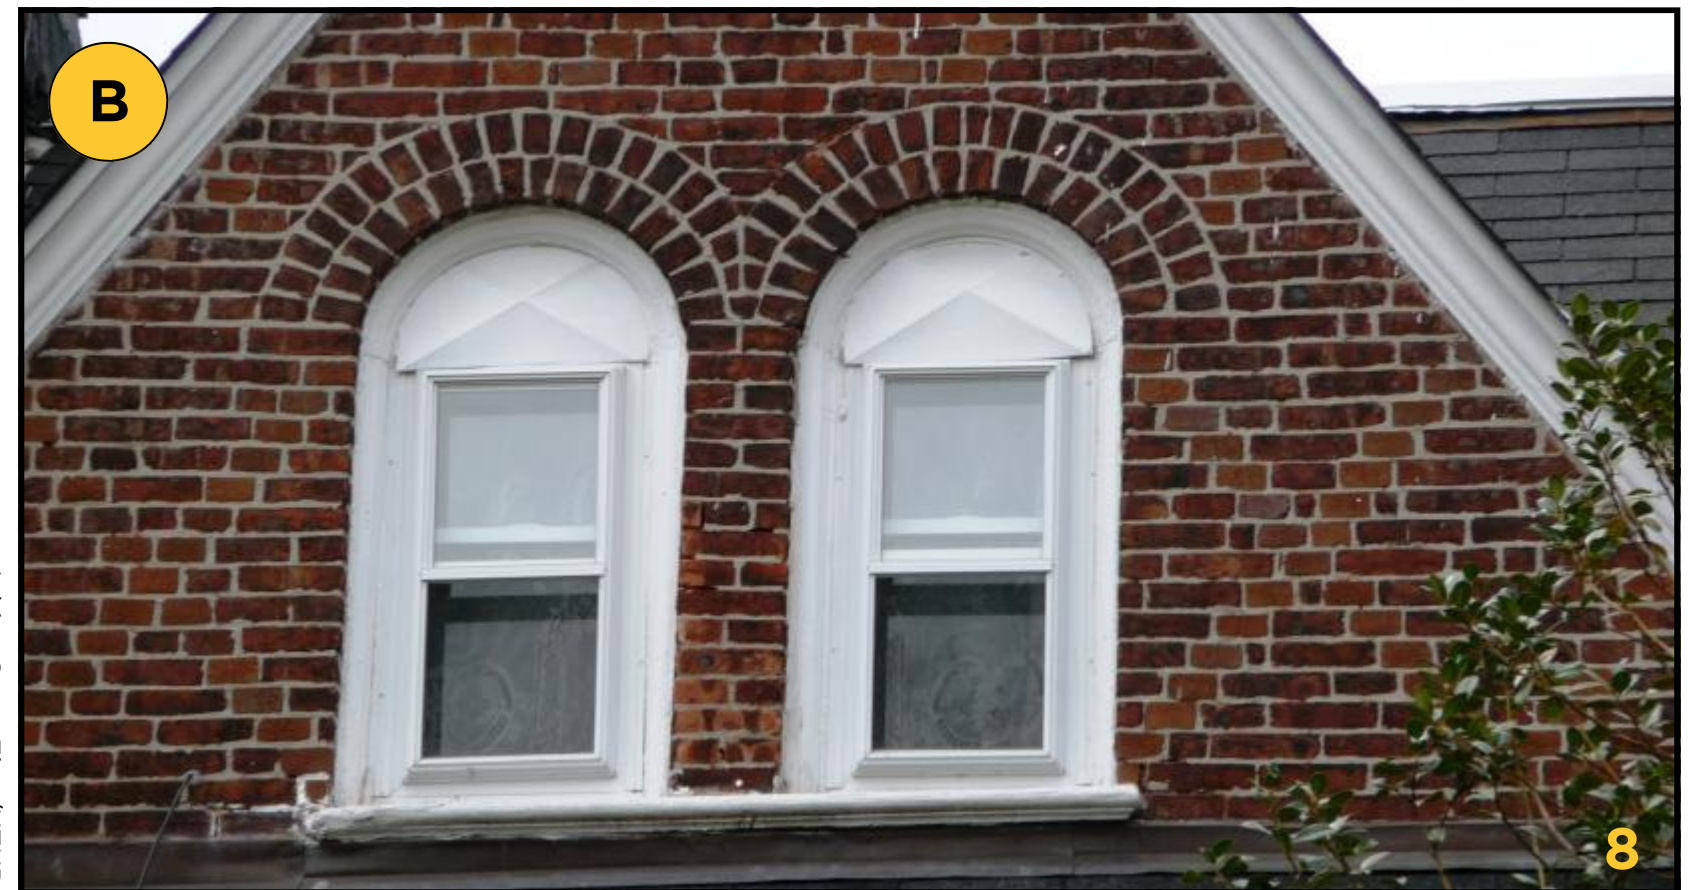
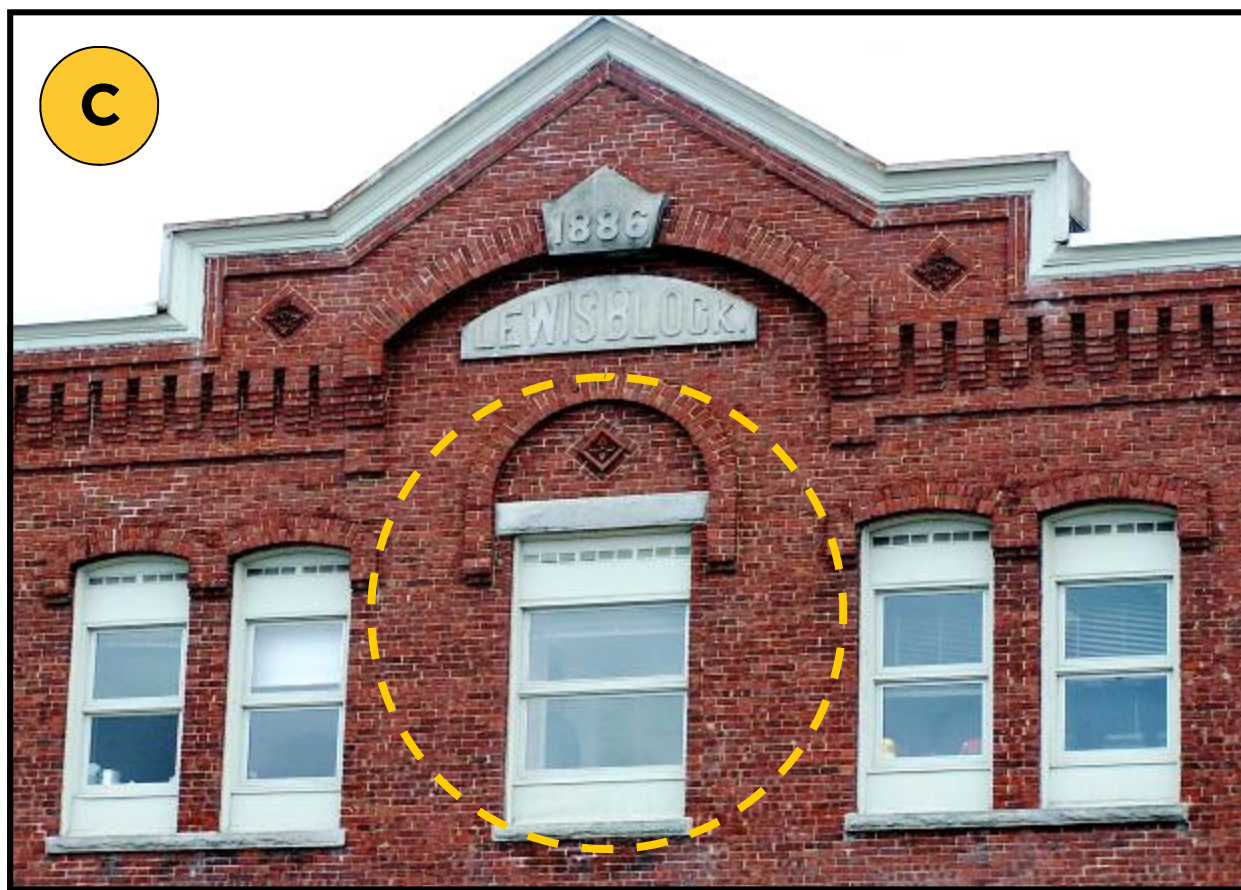
- A Two, arched nine-over-one double-hung sash windows are in disrepair with loose meeting rails and paint build up. They can be easily repaired and still maintain the character of the building.
- B An identical building with replacement windows. Stock units were used with aluminum in-fill around the opening. The difference in character between A and B is dramatic.
- C The upper story windows of this Main Street commercial structure were replaced with stock units with in-fill at the top and bottom.

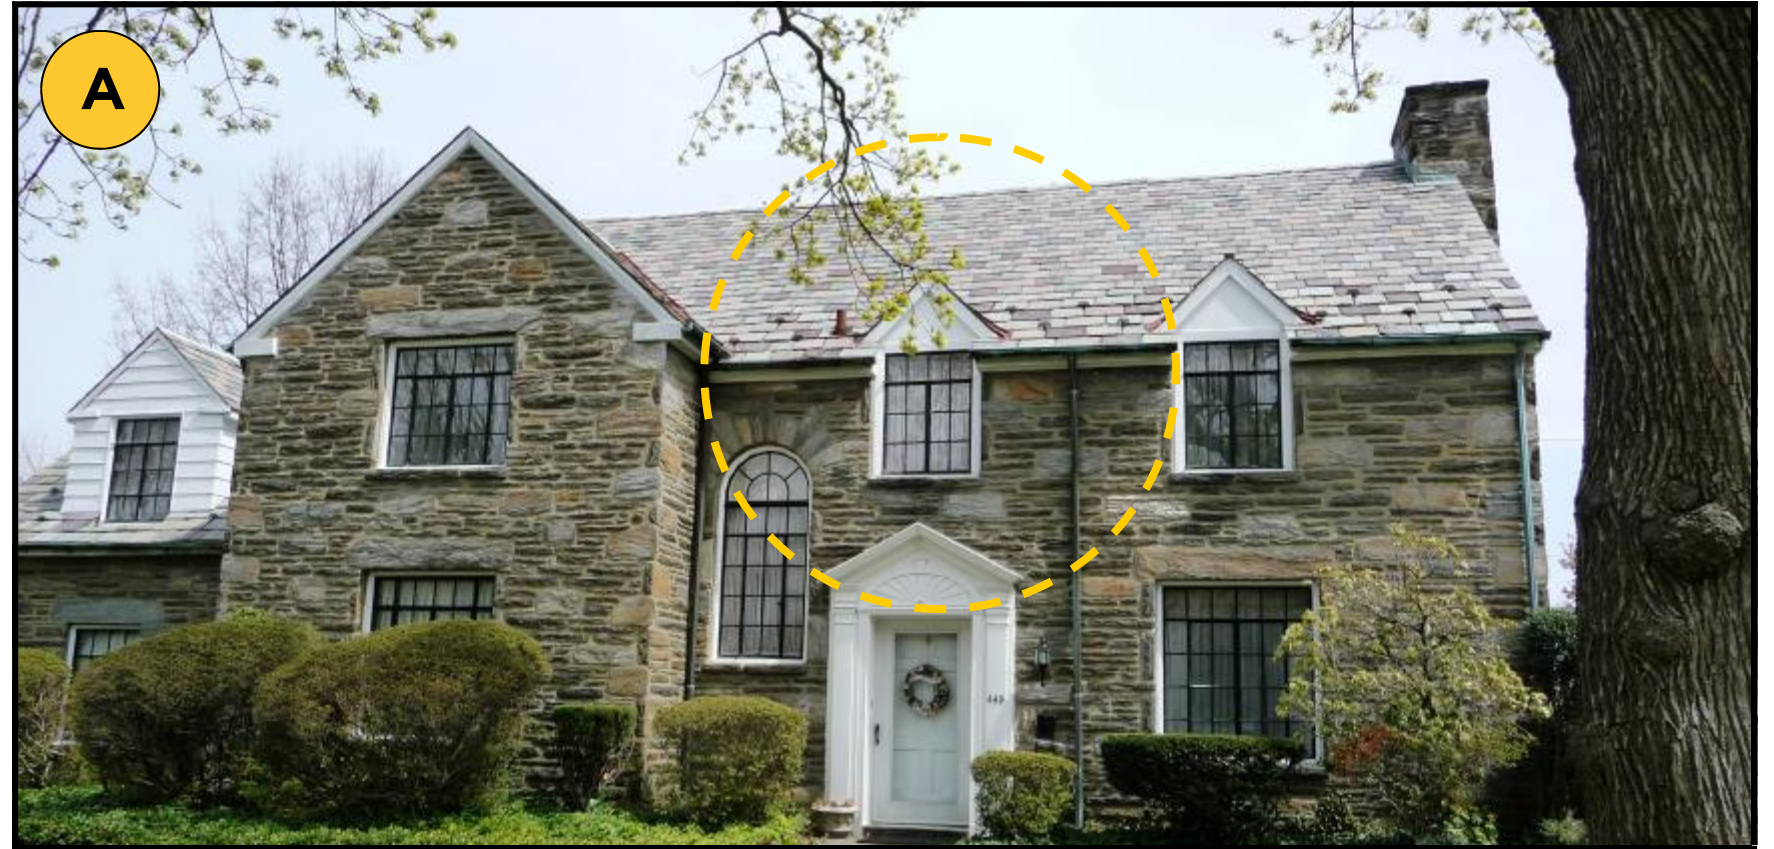
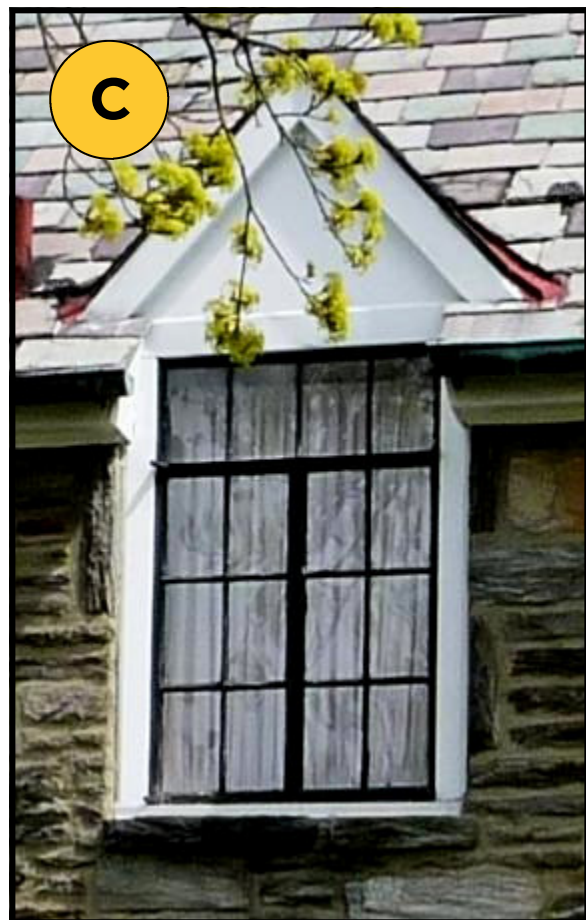
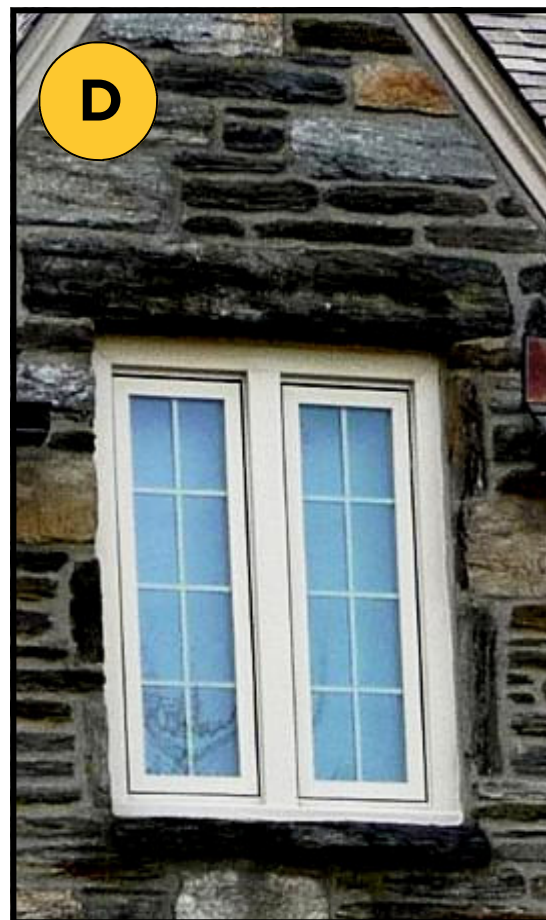
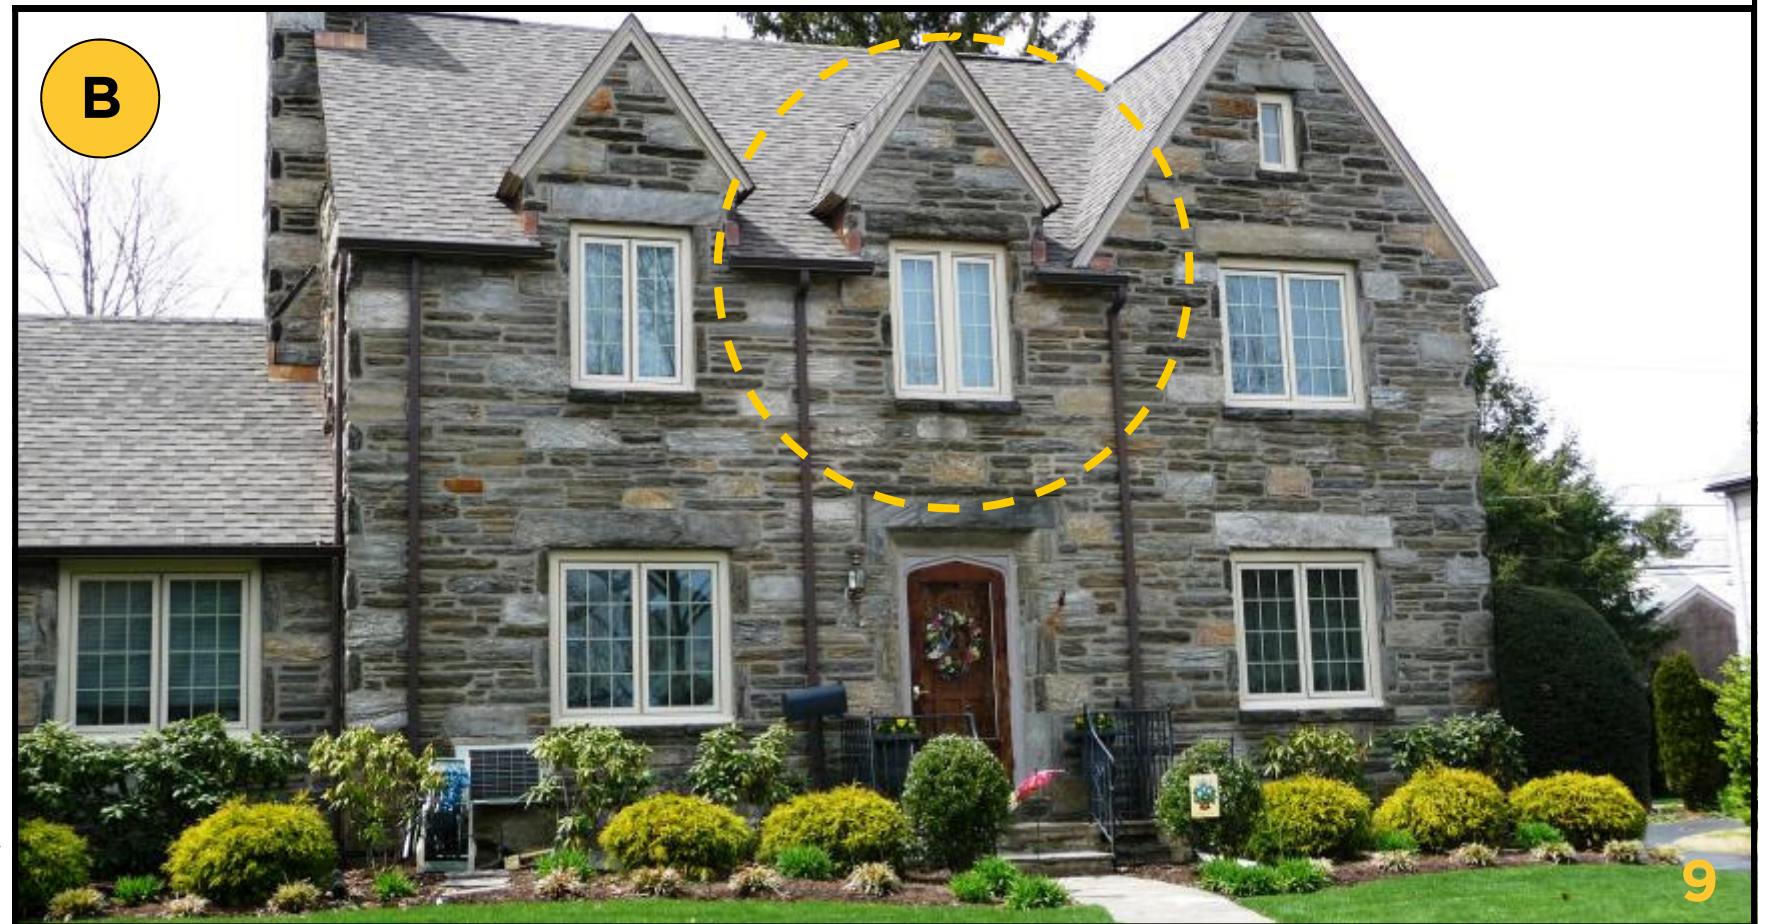
- A Steel casement windows with fixed transoms and side-lights, featuring interior storm windows. These windows are a character defining feature of the house.
- B Replacement windows attempt to match with casement style units yet the proportion, pattern, width and lack of a true divided-light miss the mark.
- C, D The differences between the original and replacement are readily seen, where the wider casing and surround are much prominent on the replacement windows.

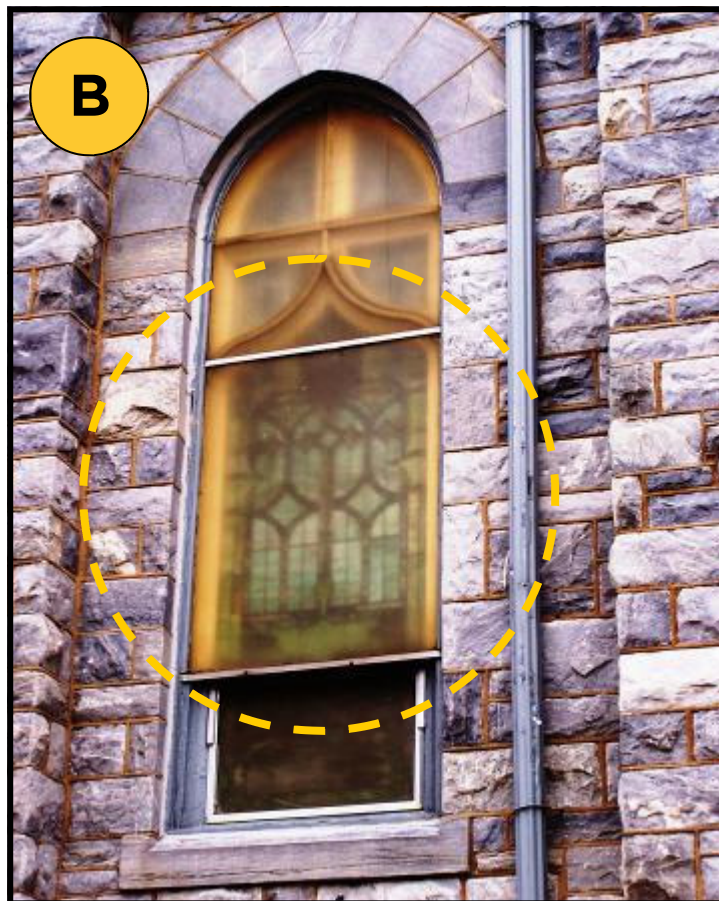
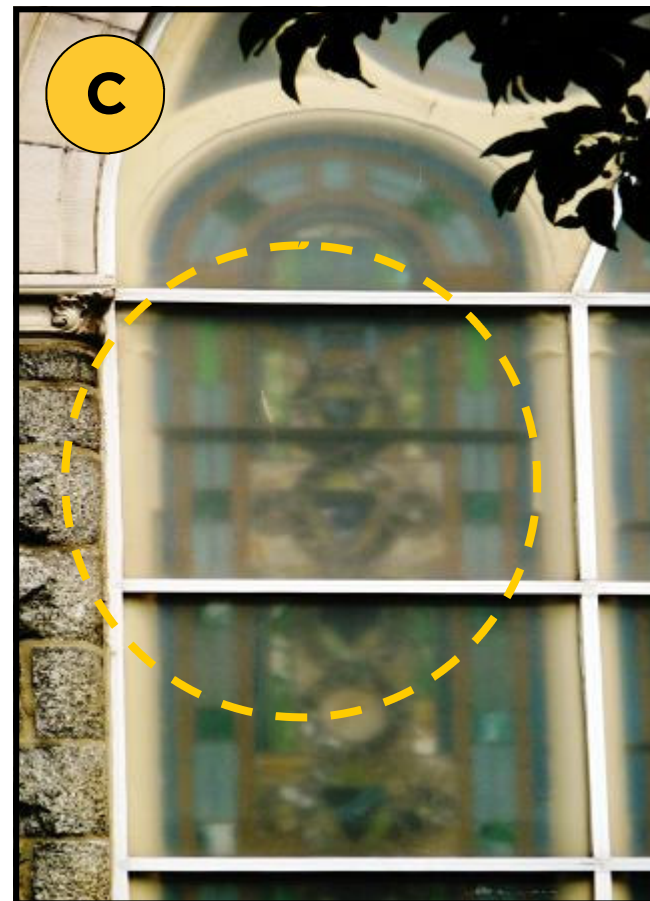
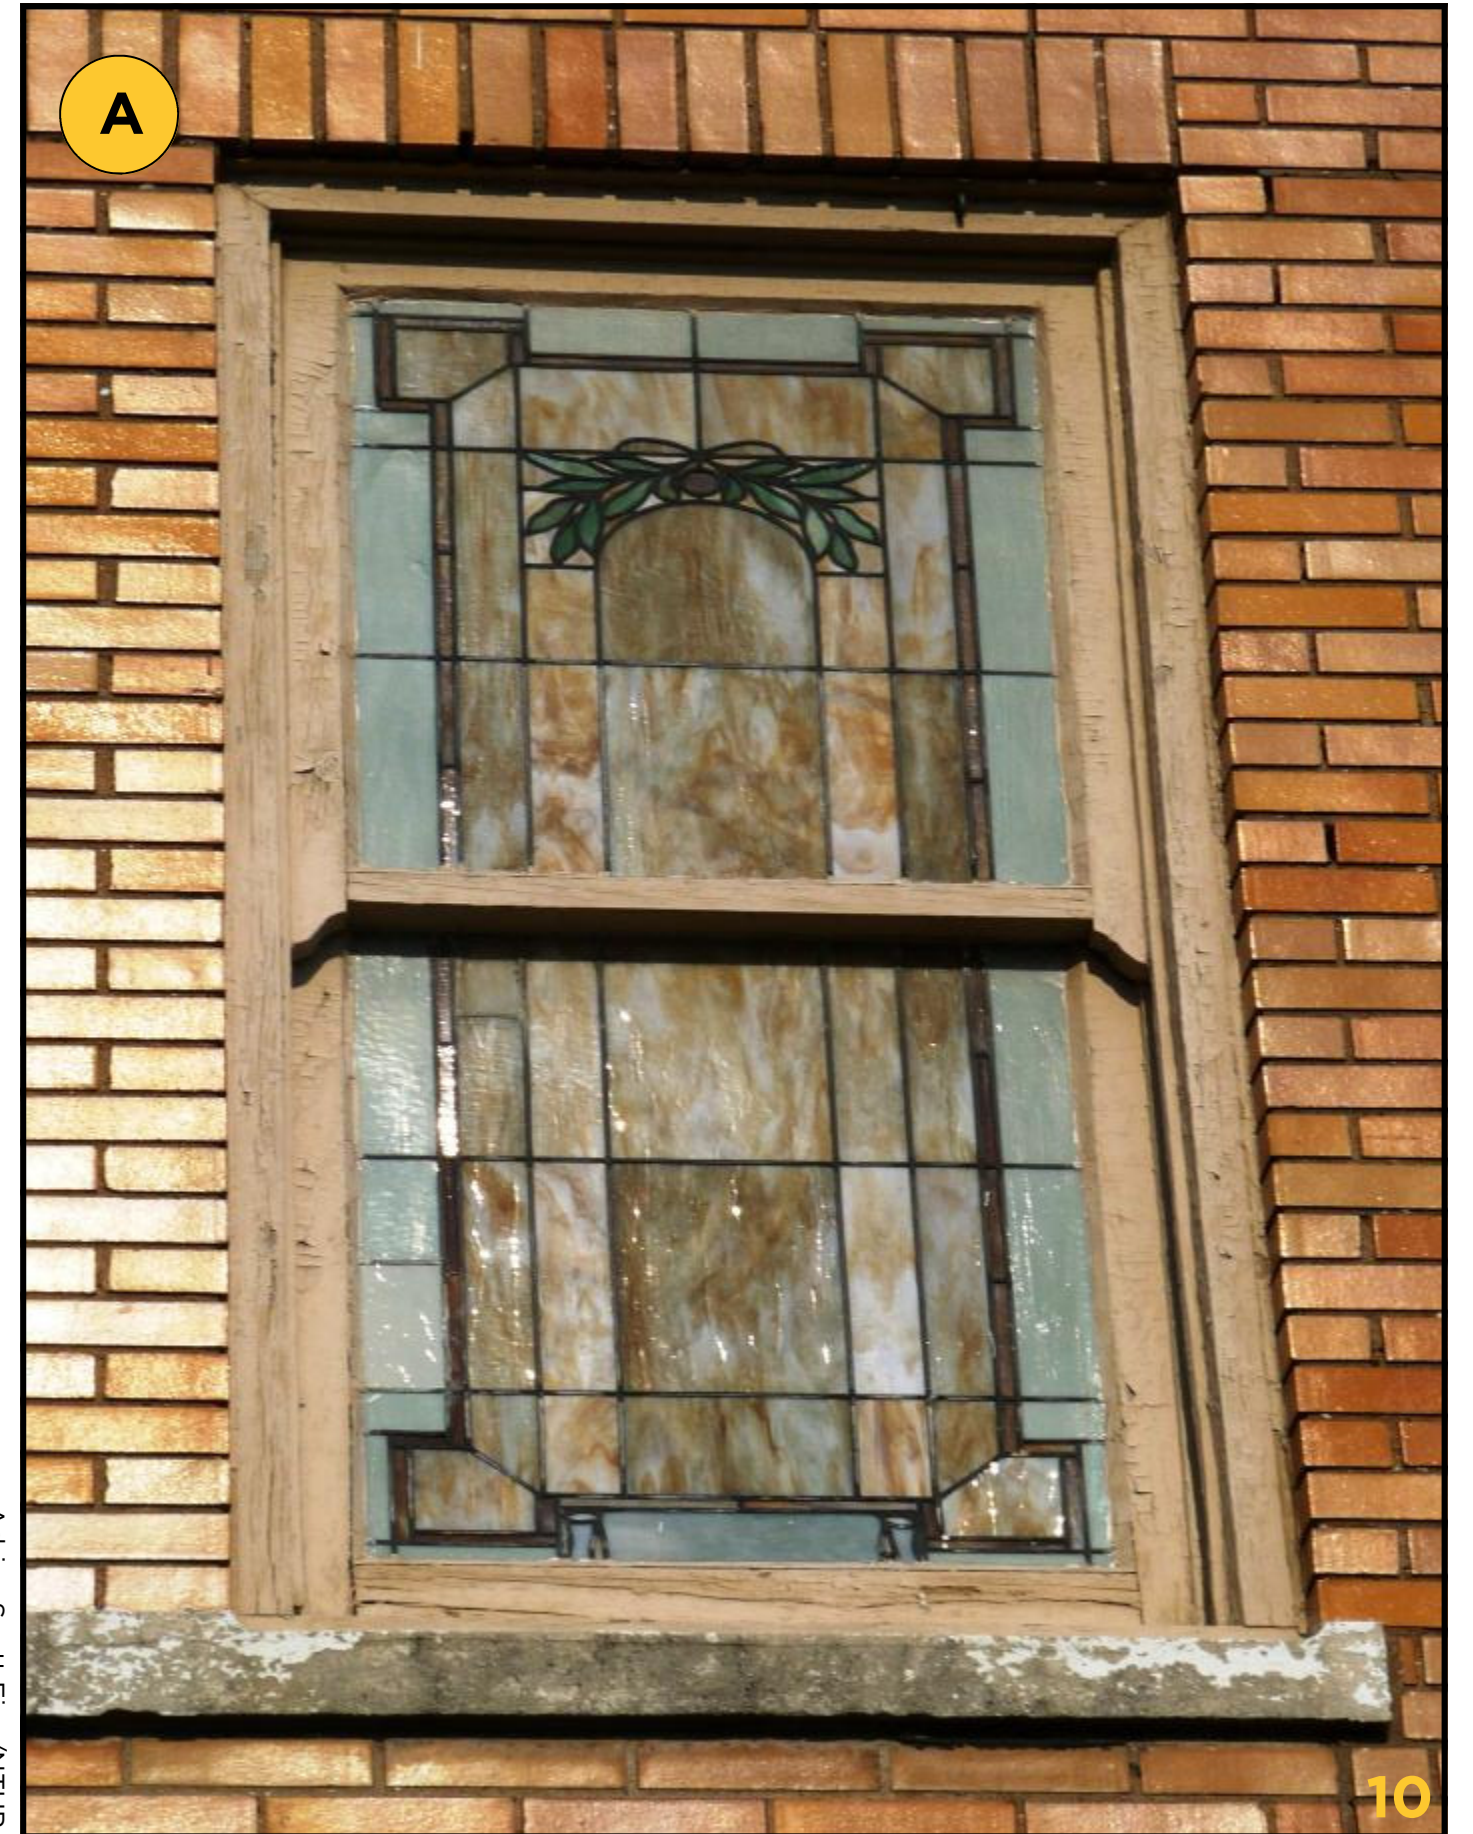
- A Exposed original one-over-one double-hung slag glass window .
- B Plastics (Lexan or Plexiglass) are impact-resistant and nearly shatter-proof but tend to yellow and get hazy over time.
- C Windows are obscured and the pattern is dramatically altered with new aluminum rails as part of this protective glazing system.

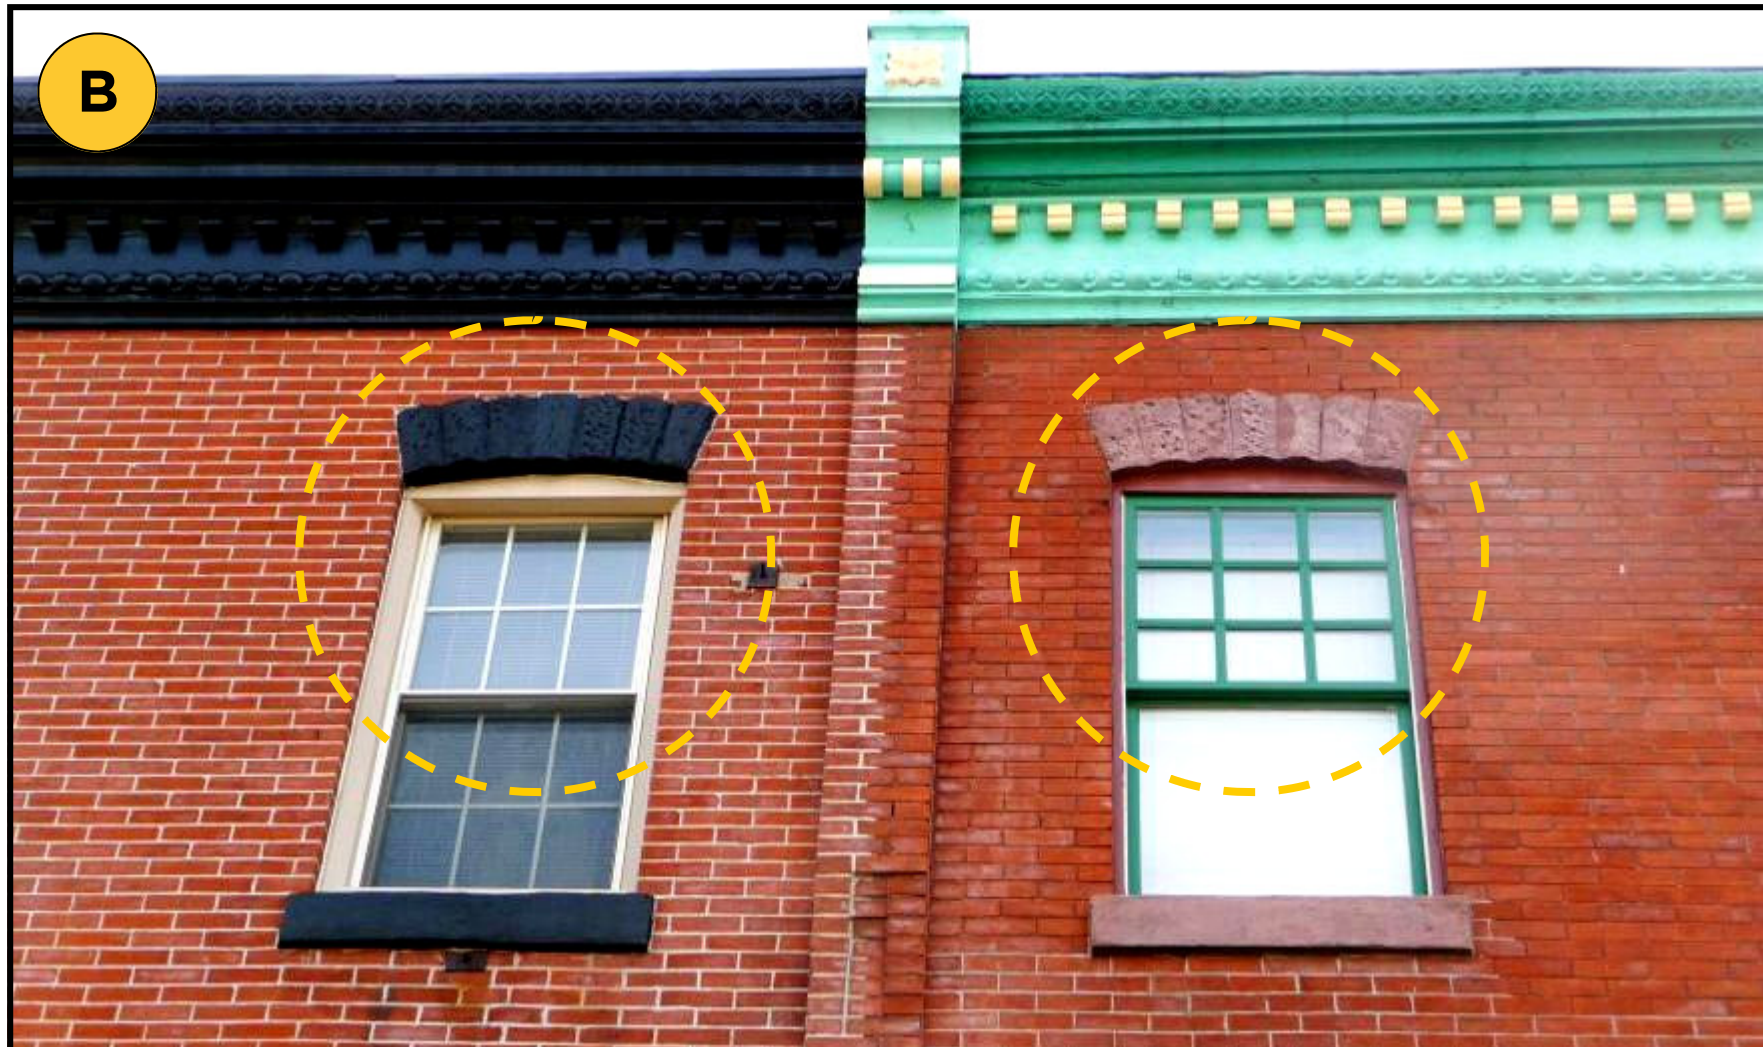
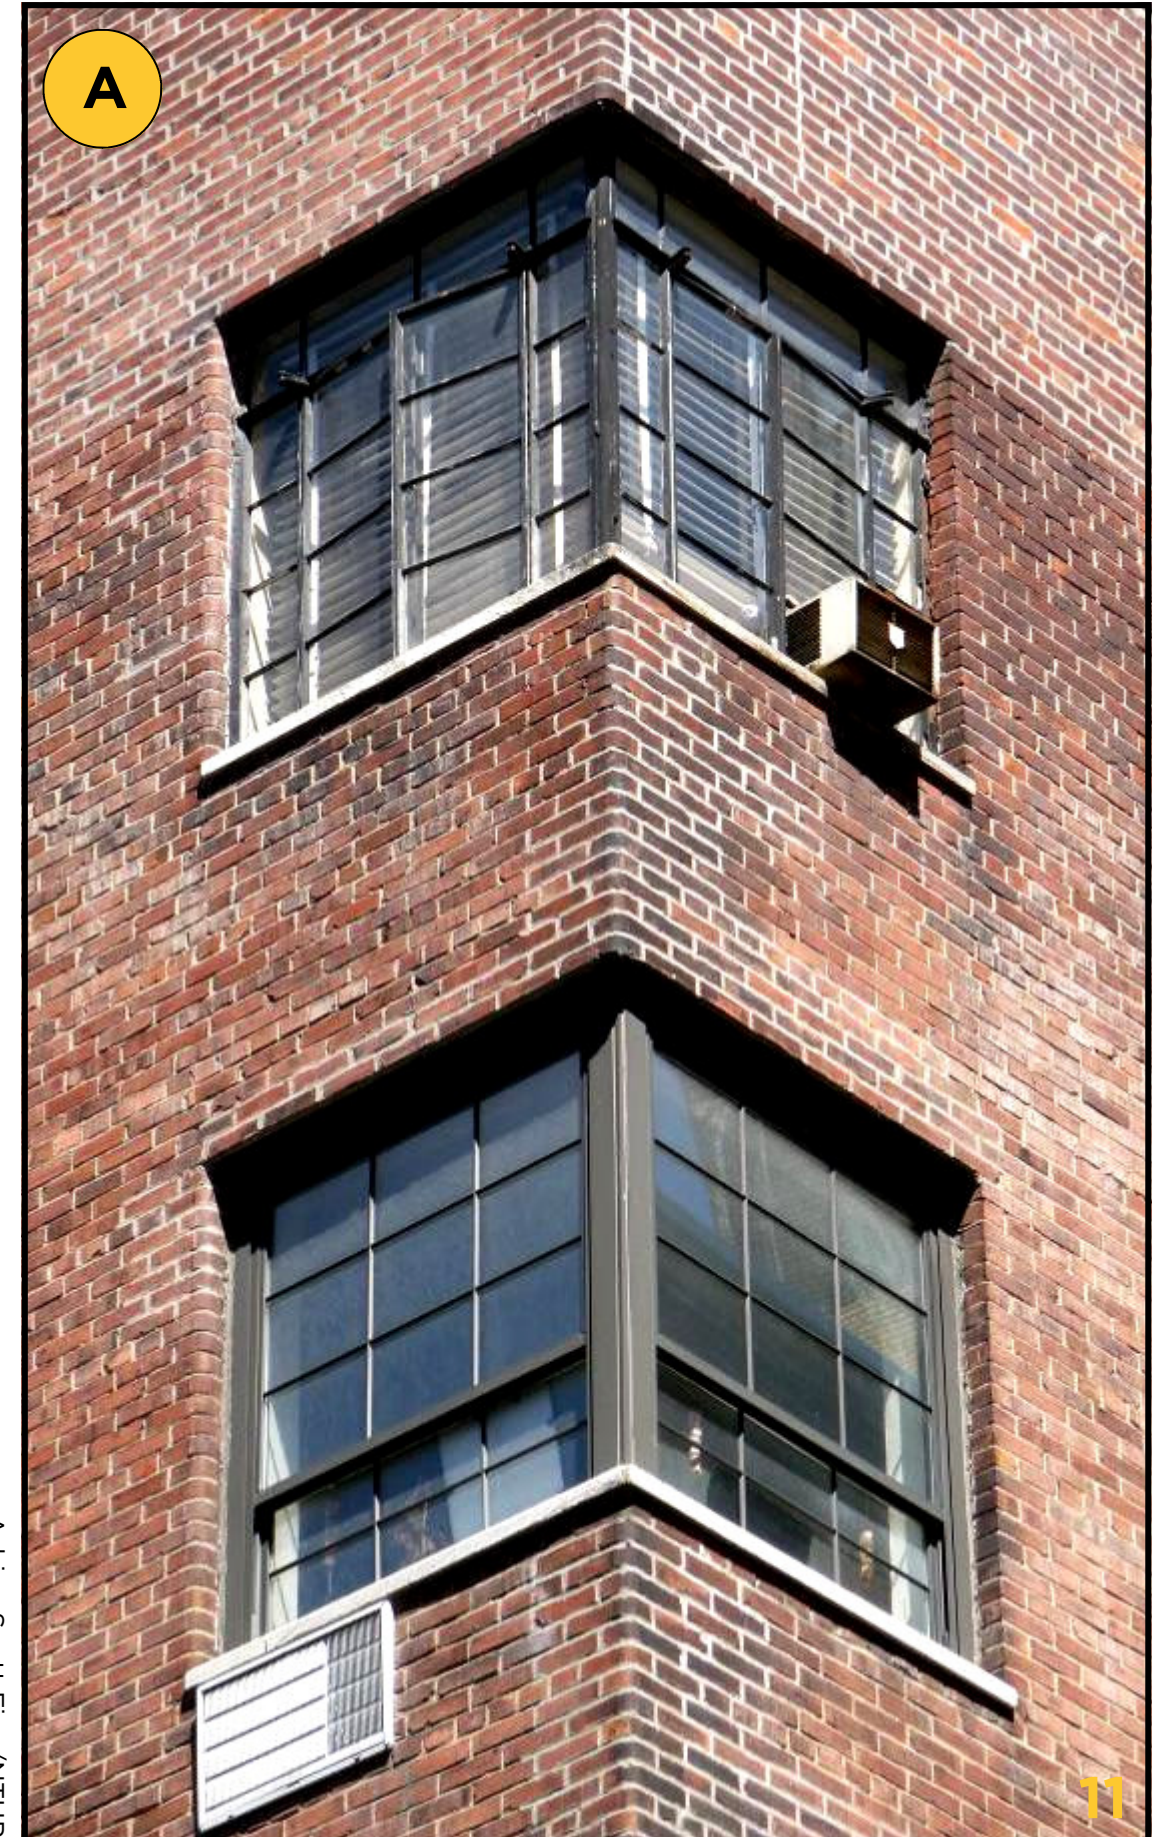
- A An early 1940s apartment building designed in the Art Deco style features corner, steel casement windows. The slender profile of the muntins and casing is a character defining feature. The replacement double-hung sash window, at the bottom, attempts to match the lines of the original, yet the muntin pattern and width of casing are much different.
- B Two double-hung sash replacement windows on side-by-side row houses demonstrate the subtle, but noticeable differences in design. While original windows were identical, these are different in terms of depth, muntin size and pattern and width of casing.
