NATIONAL  
TRUST  
FOR  
HISTORIC  
PRESERVATION®

# Repair or Replace Old Windows

**A Visual Look at the Impacts**

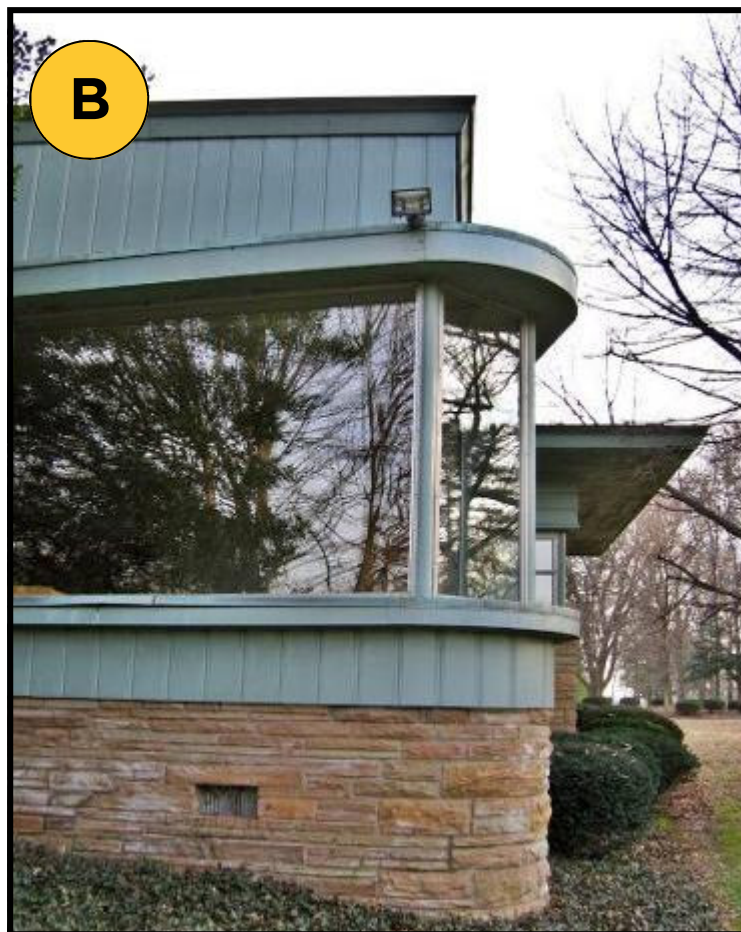
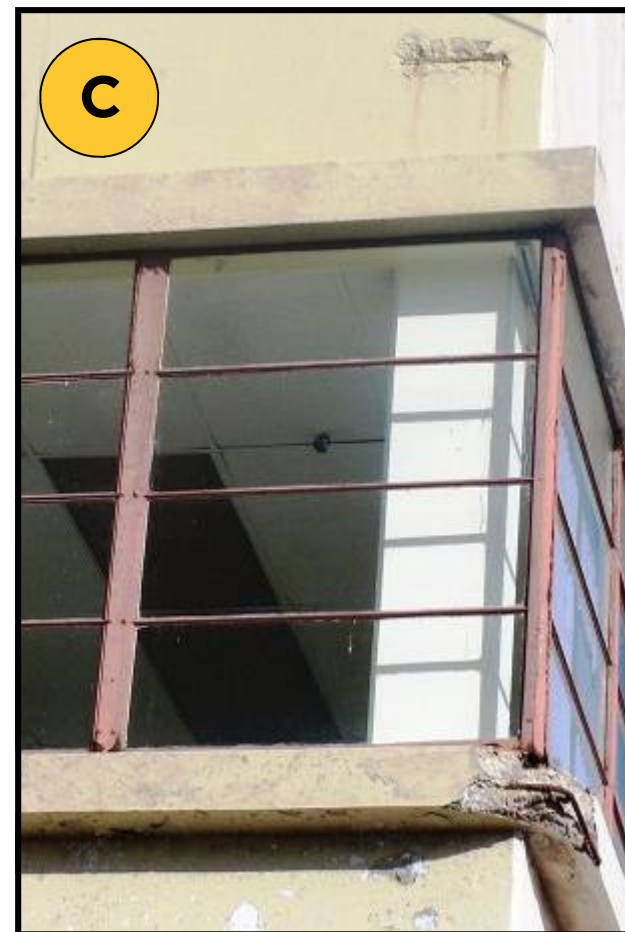
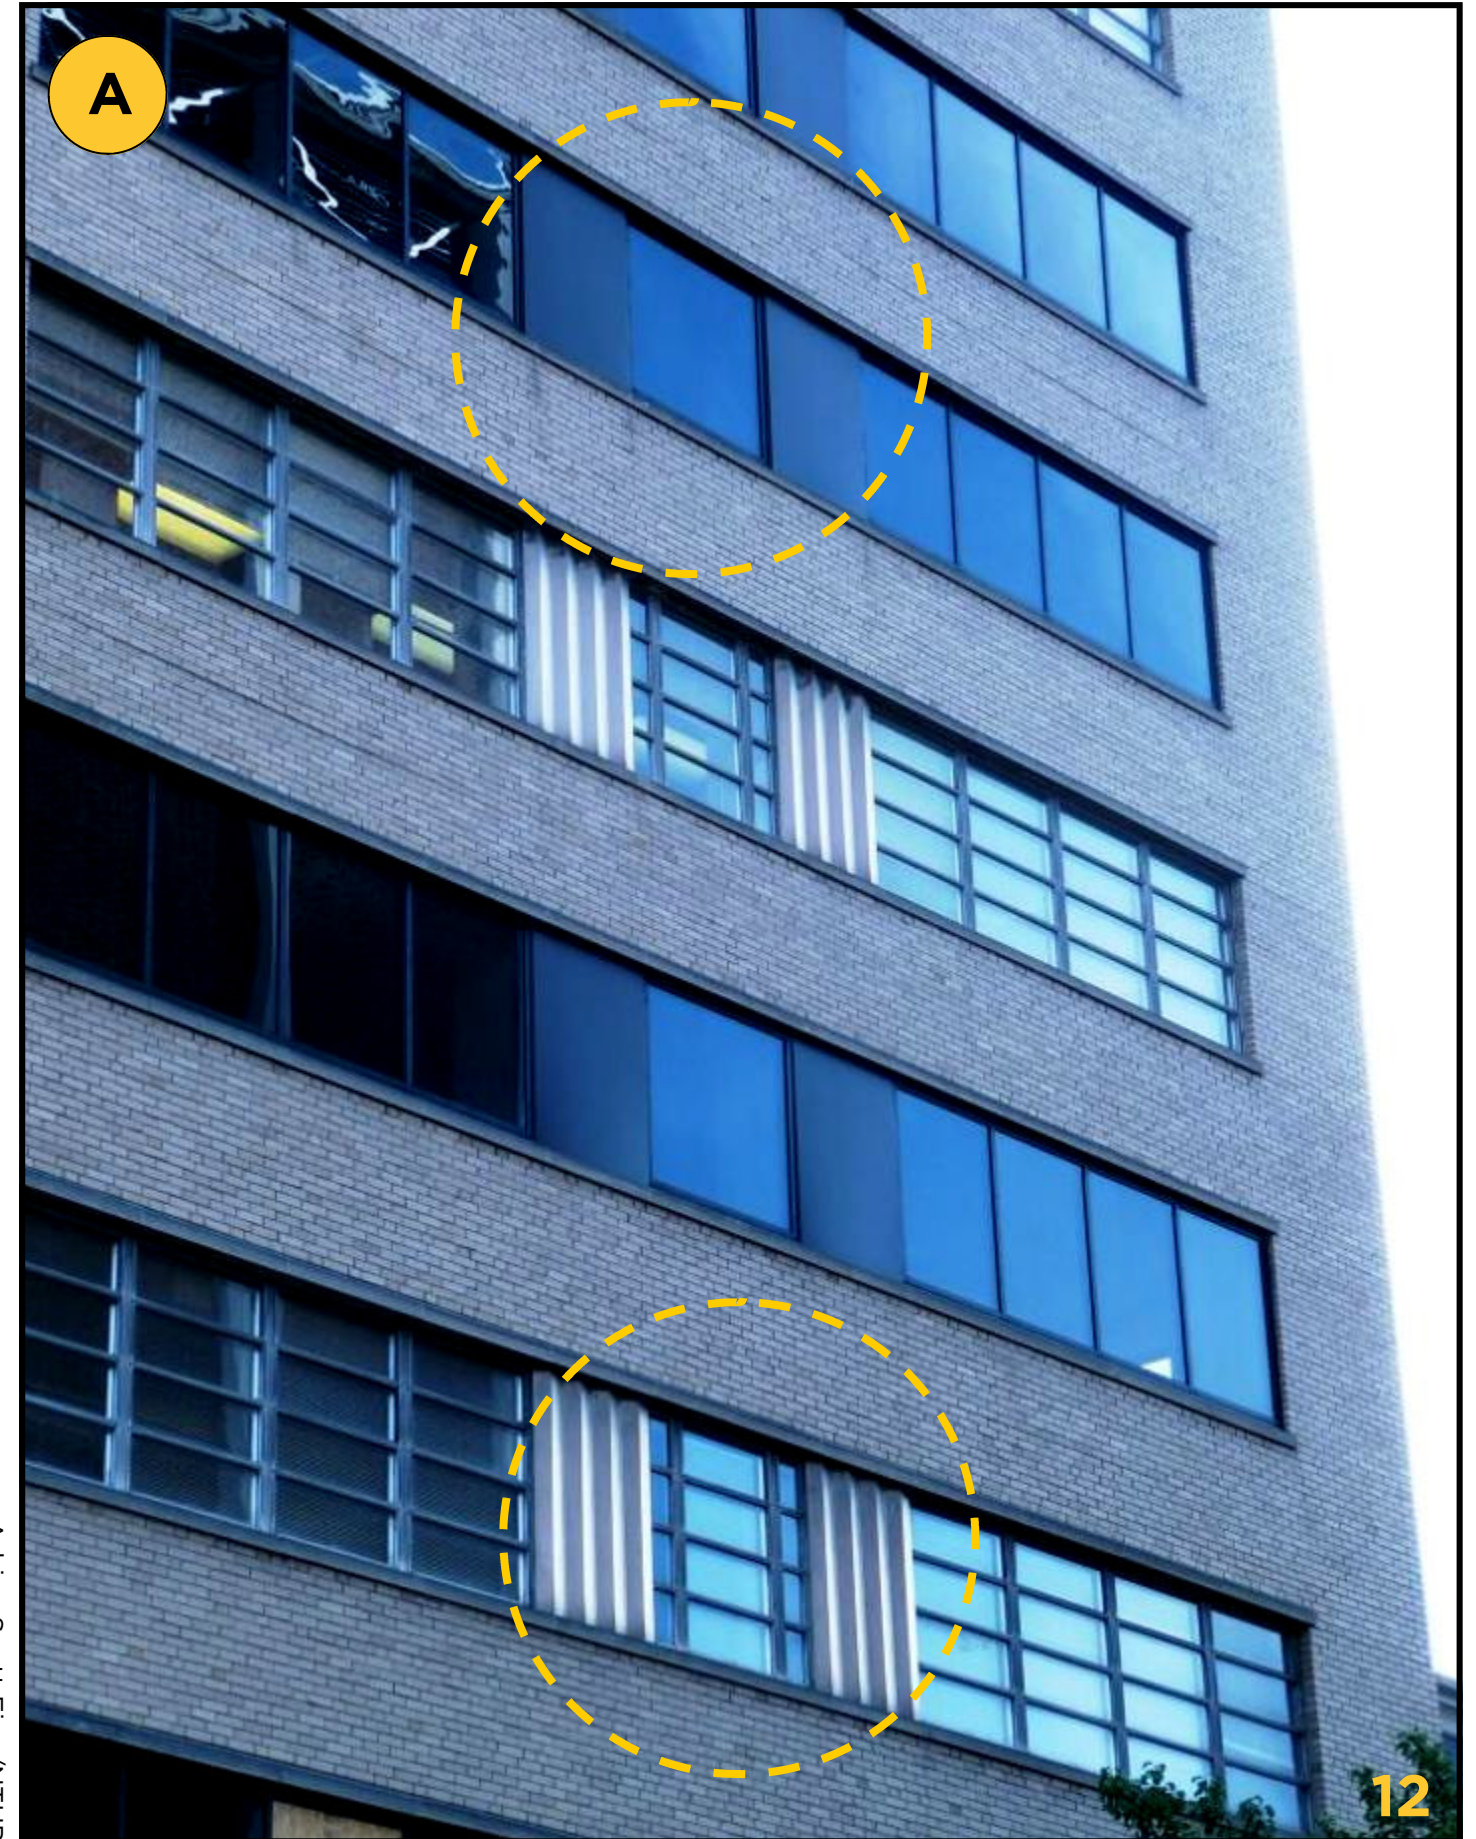
- A Original, character defining windows and corrugated stainless steel detail are being removed on this 1950s office building, replaced by dark tinted fixed windows that do not match.
- B, C Large spans of single pane and plate glass require innovative solutions, such as custom designed storm windows.

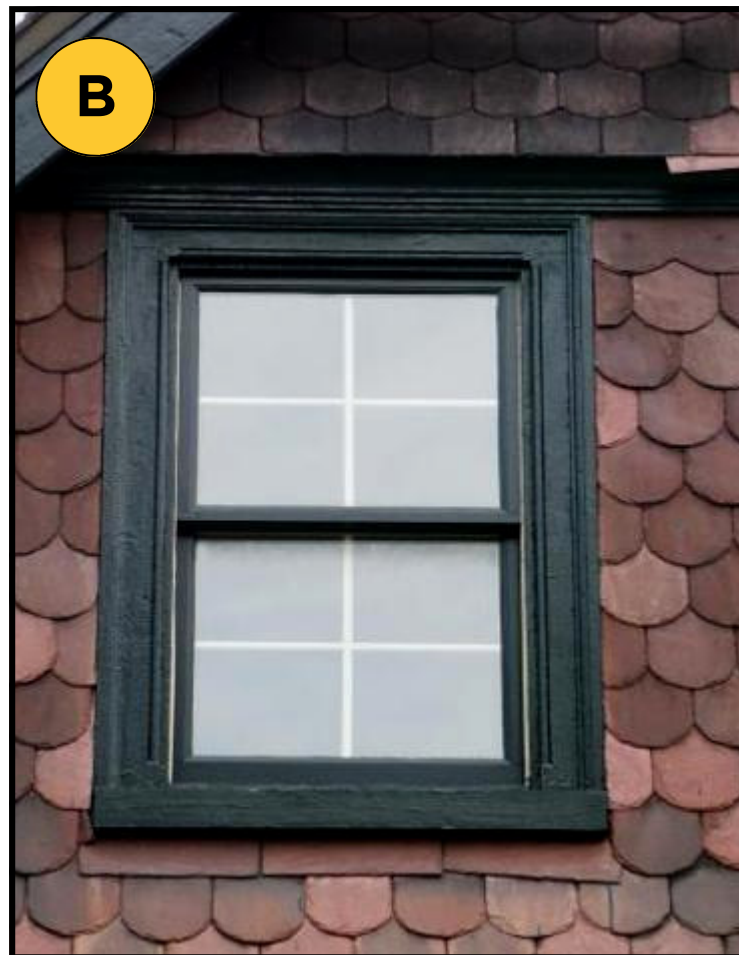
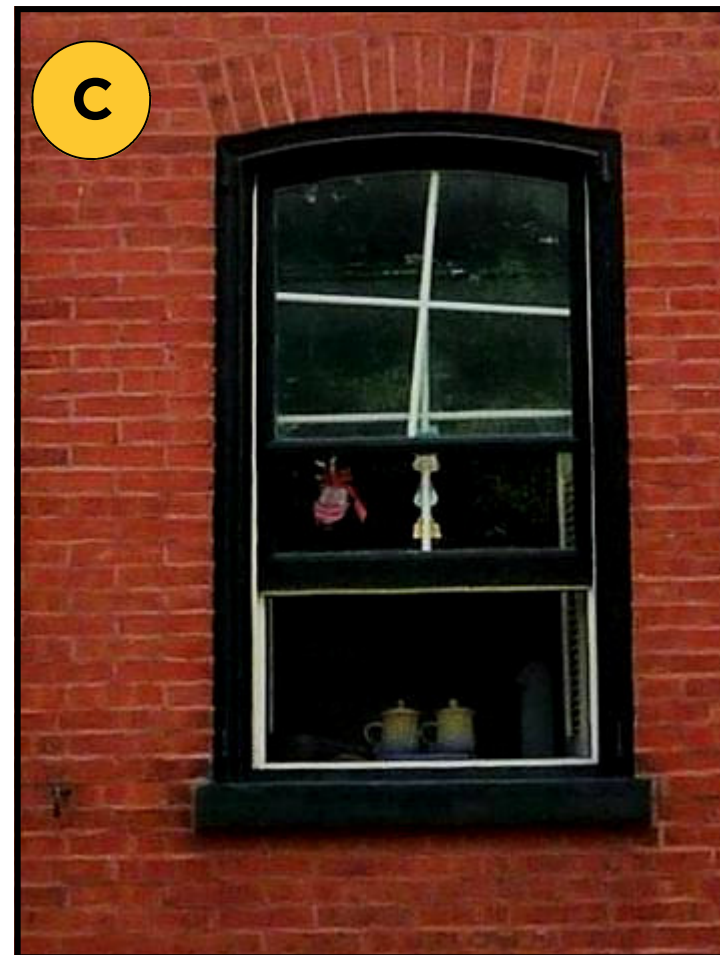
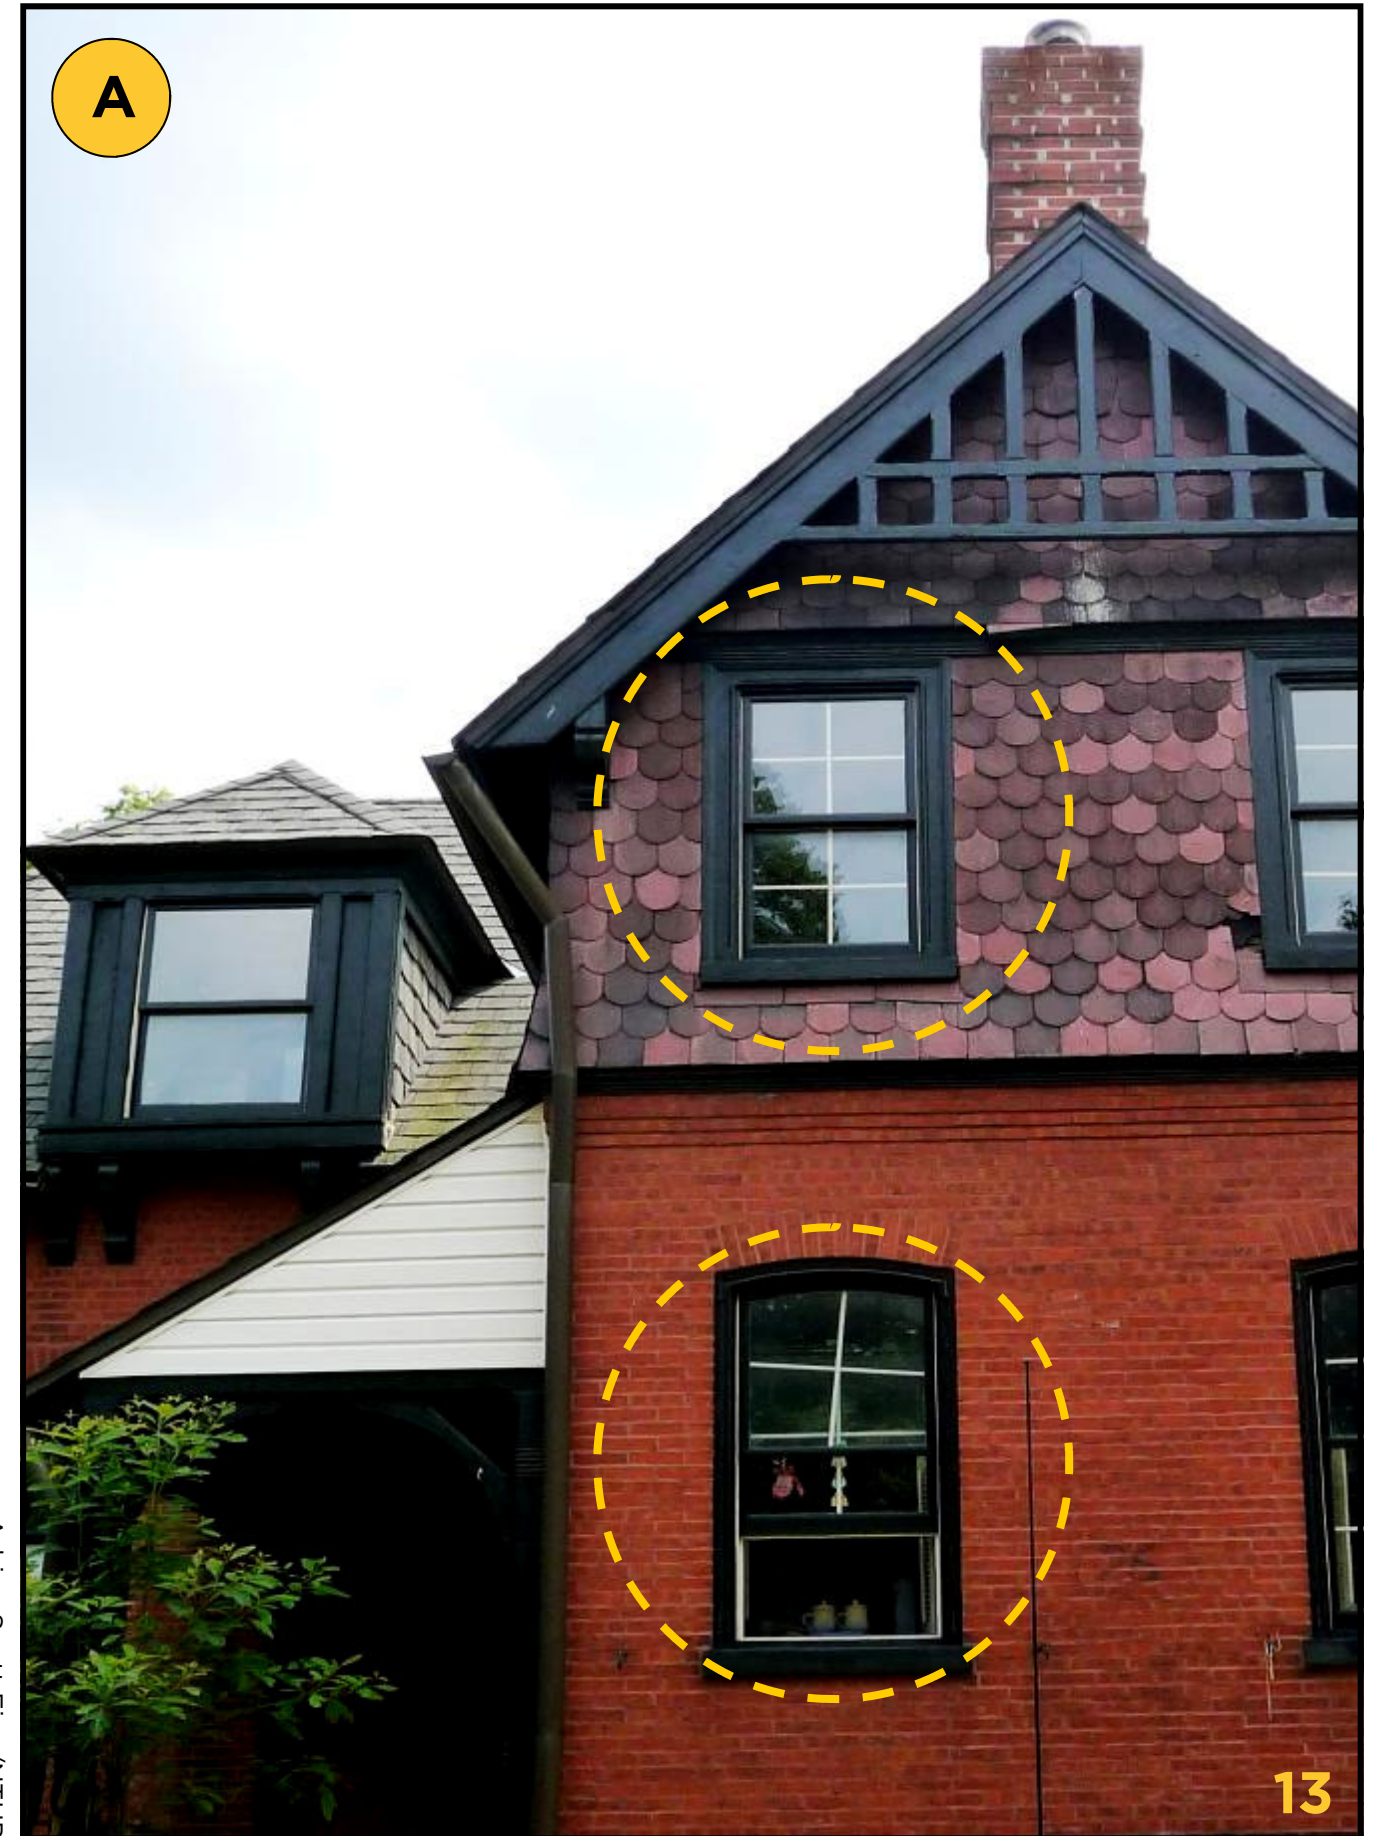
- A A former carriage house, rehabilitated and preserved for a new use, features replacement windows that attempt to look like true divided-light windows.
- B This four-over-four double-hung sash still has its original wood casing with a replacement window with clipped on interior muntins. There is little dimension or depth with this design and instead looks like a one-over-one sash.
- C This shows how clipped on interior muntins can loosen or fall off.

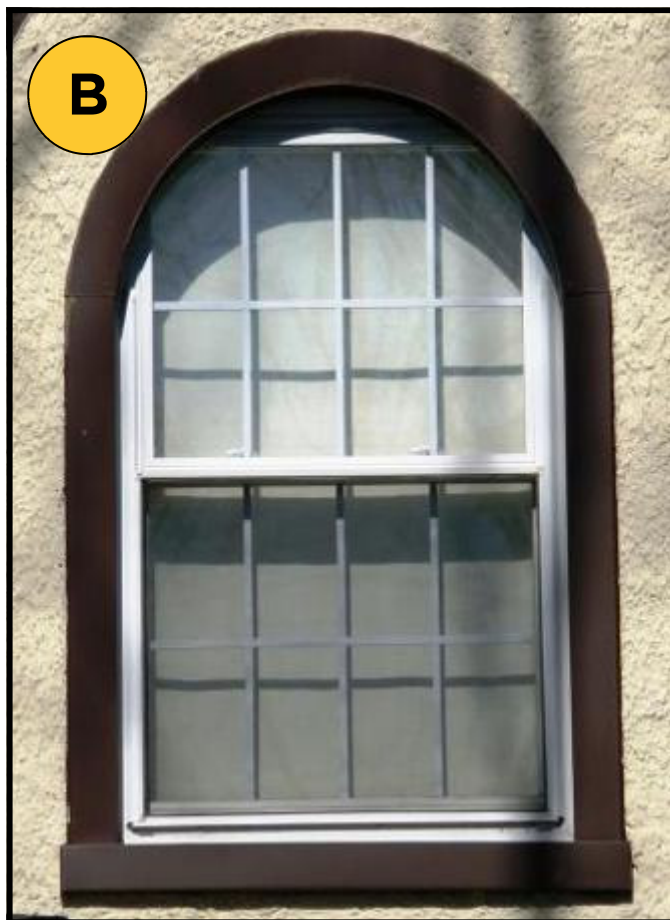
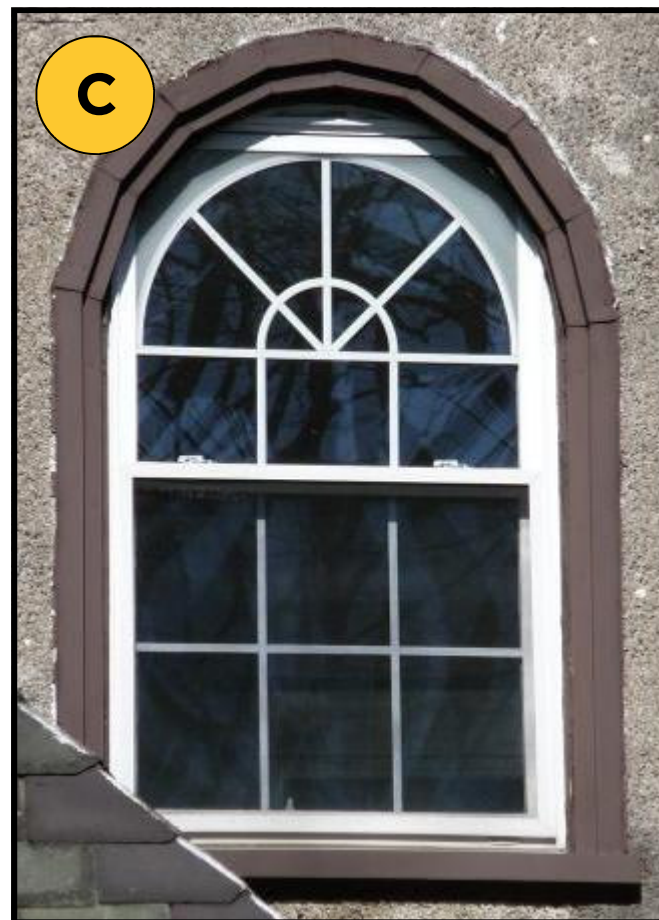
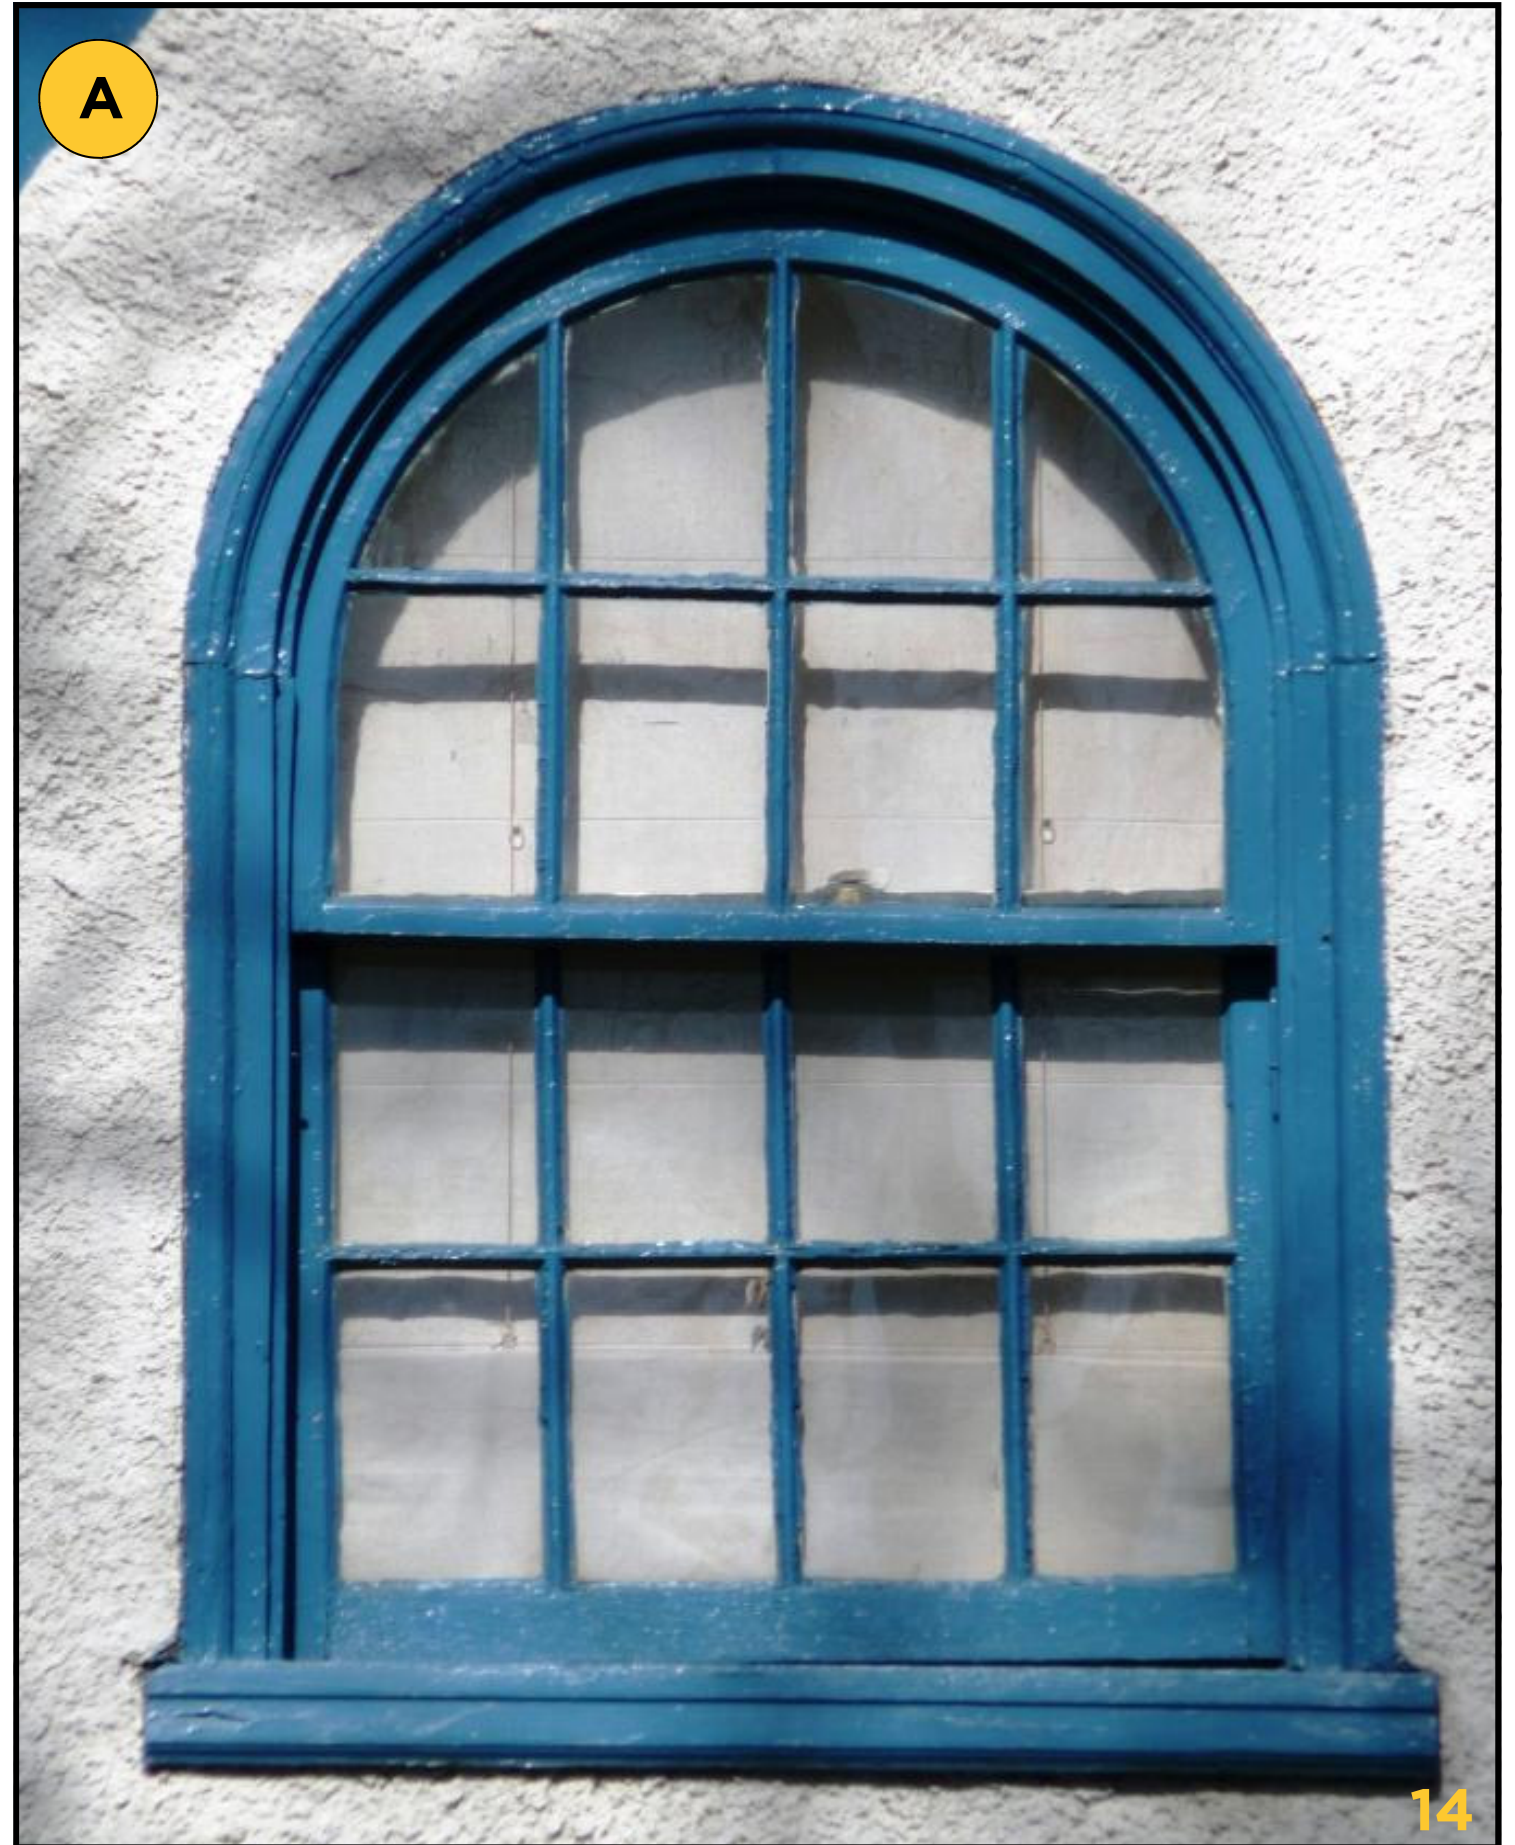
- A This eight-over-eight double-hung sash window with wood casing and sill is a common feature on houses in this neighborhood.
- B This replacement window attempts to replicate details of the original. However, it is not a true divided-light, the casing is wrapped in aluminum and the upper sash is flat and not round arched.
- C This replacement tries to look like a round arched window but is instead flat, features a completely different muntin pattern, has casing wrapped in aluminum and is not a true divided-light.

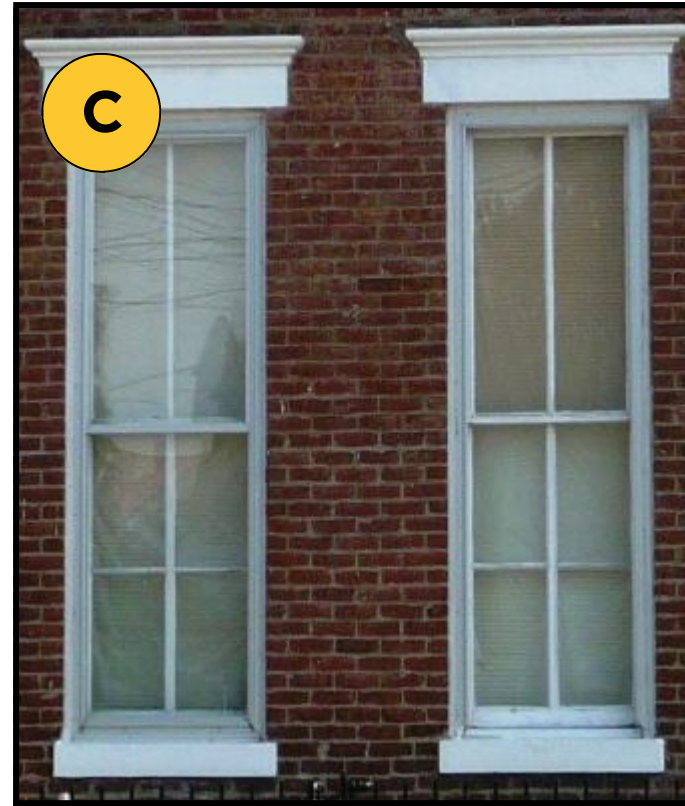
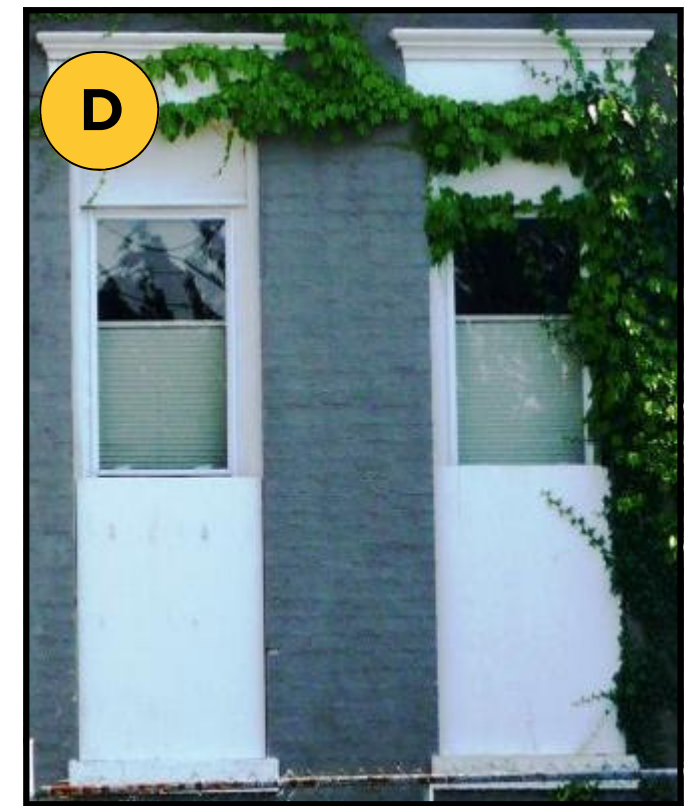
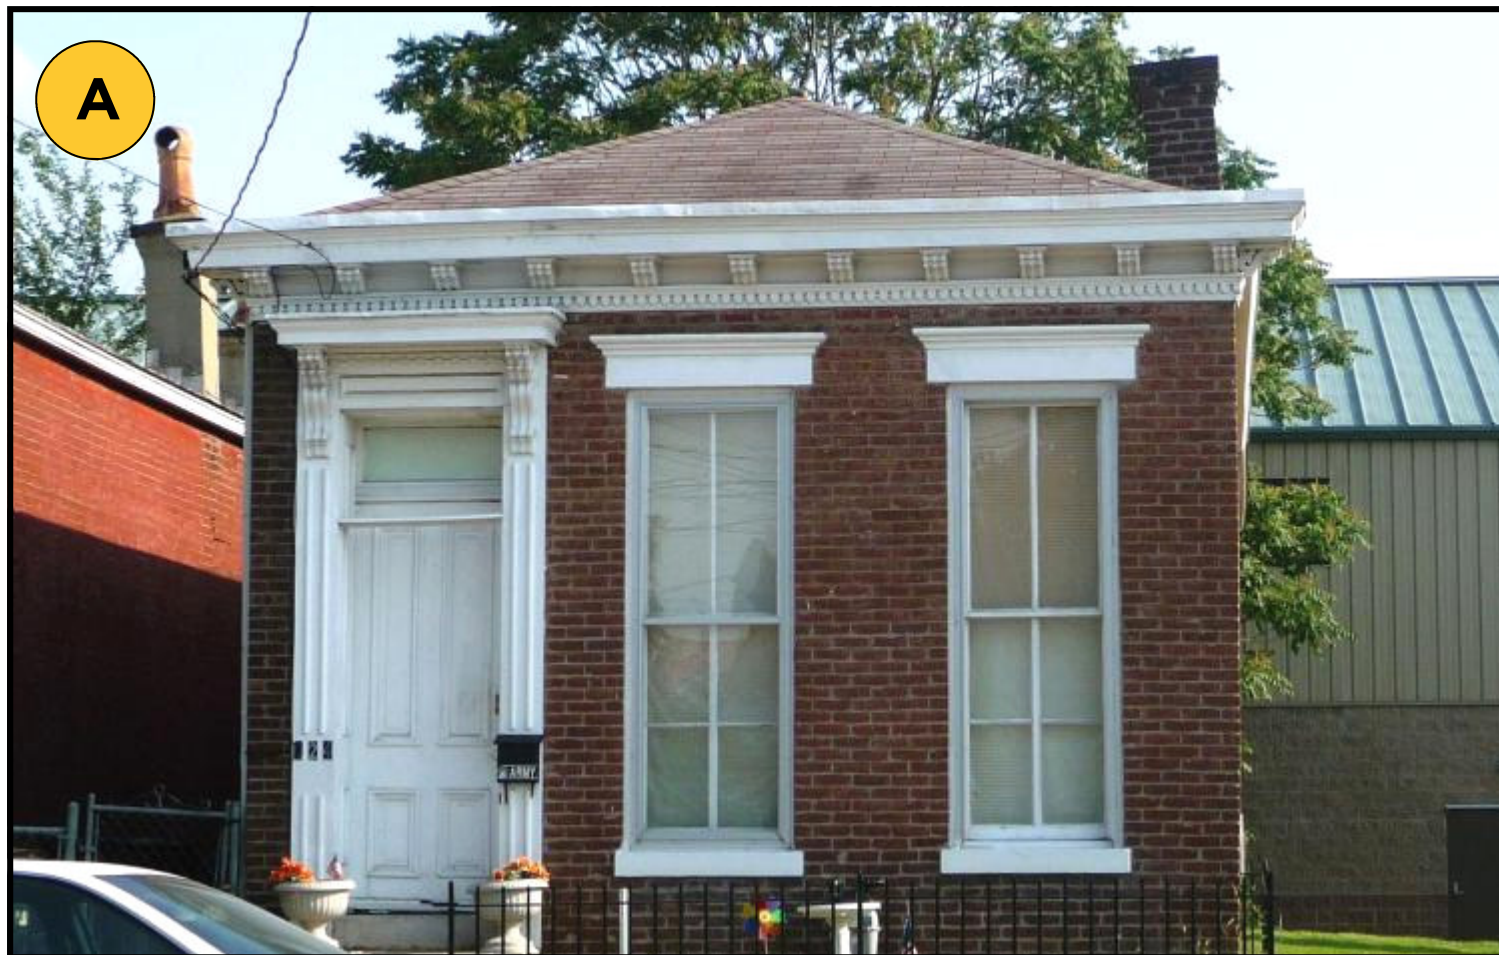
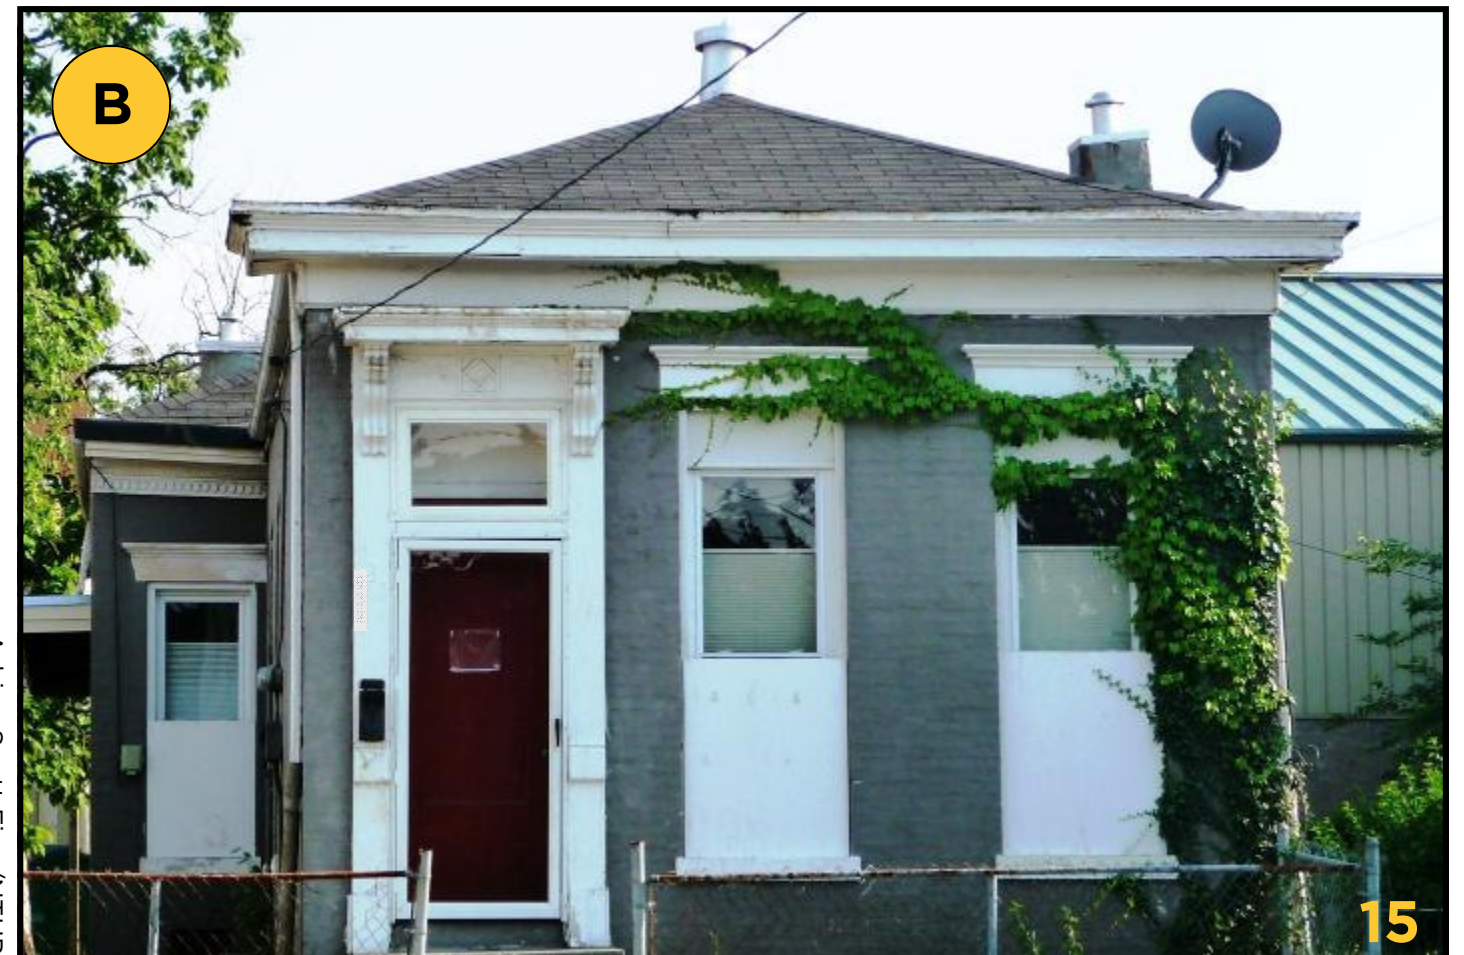
- A, B Two simple Shotgun style homes that were once nearly identical, to each other, and throughout the neighborhood.
- C Original two-over-two double-hung windows are a very prominent feature of these homes, directly relating to the size of the main entrance.
- D. The original windows were replaced, the openings reduced, and stock windows installed that are no longer in scale to the proportions of the house.

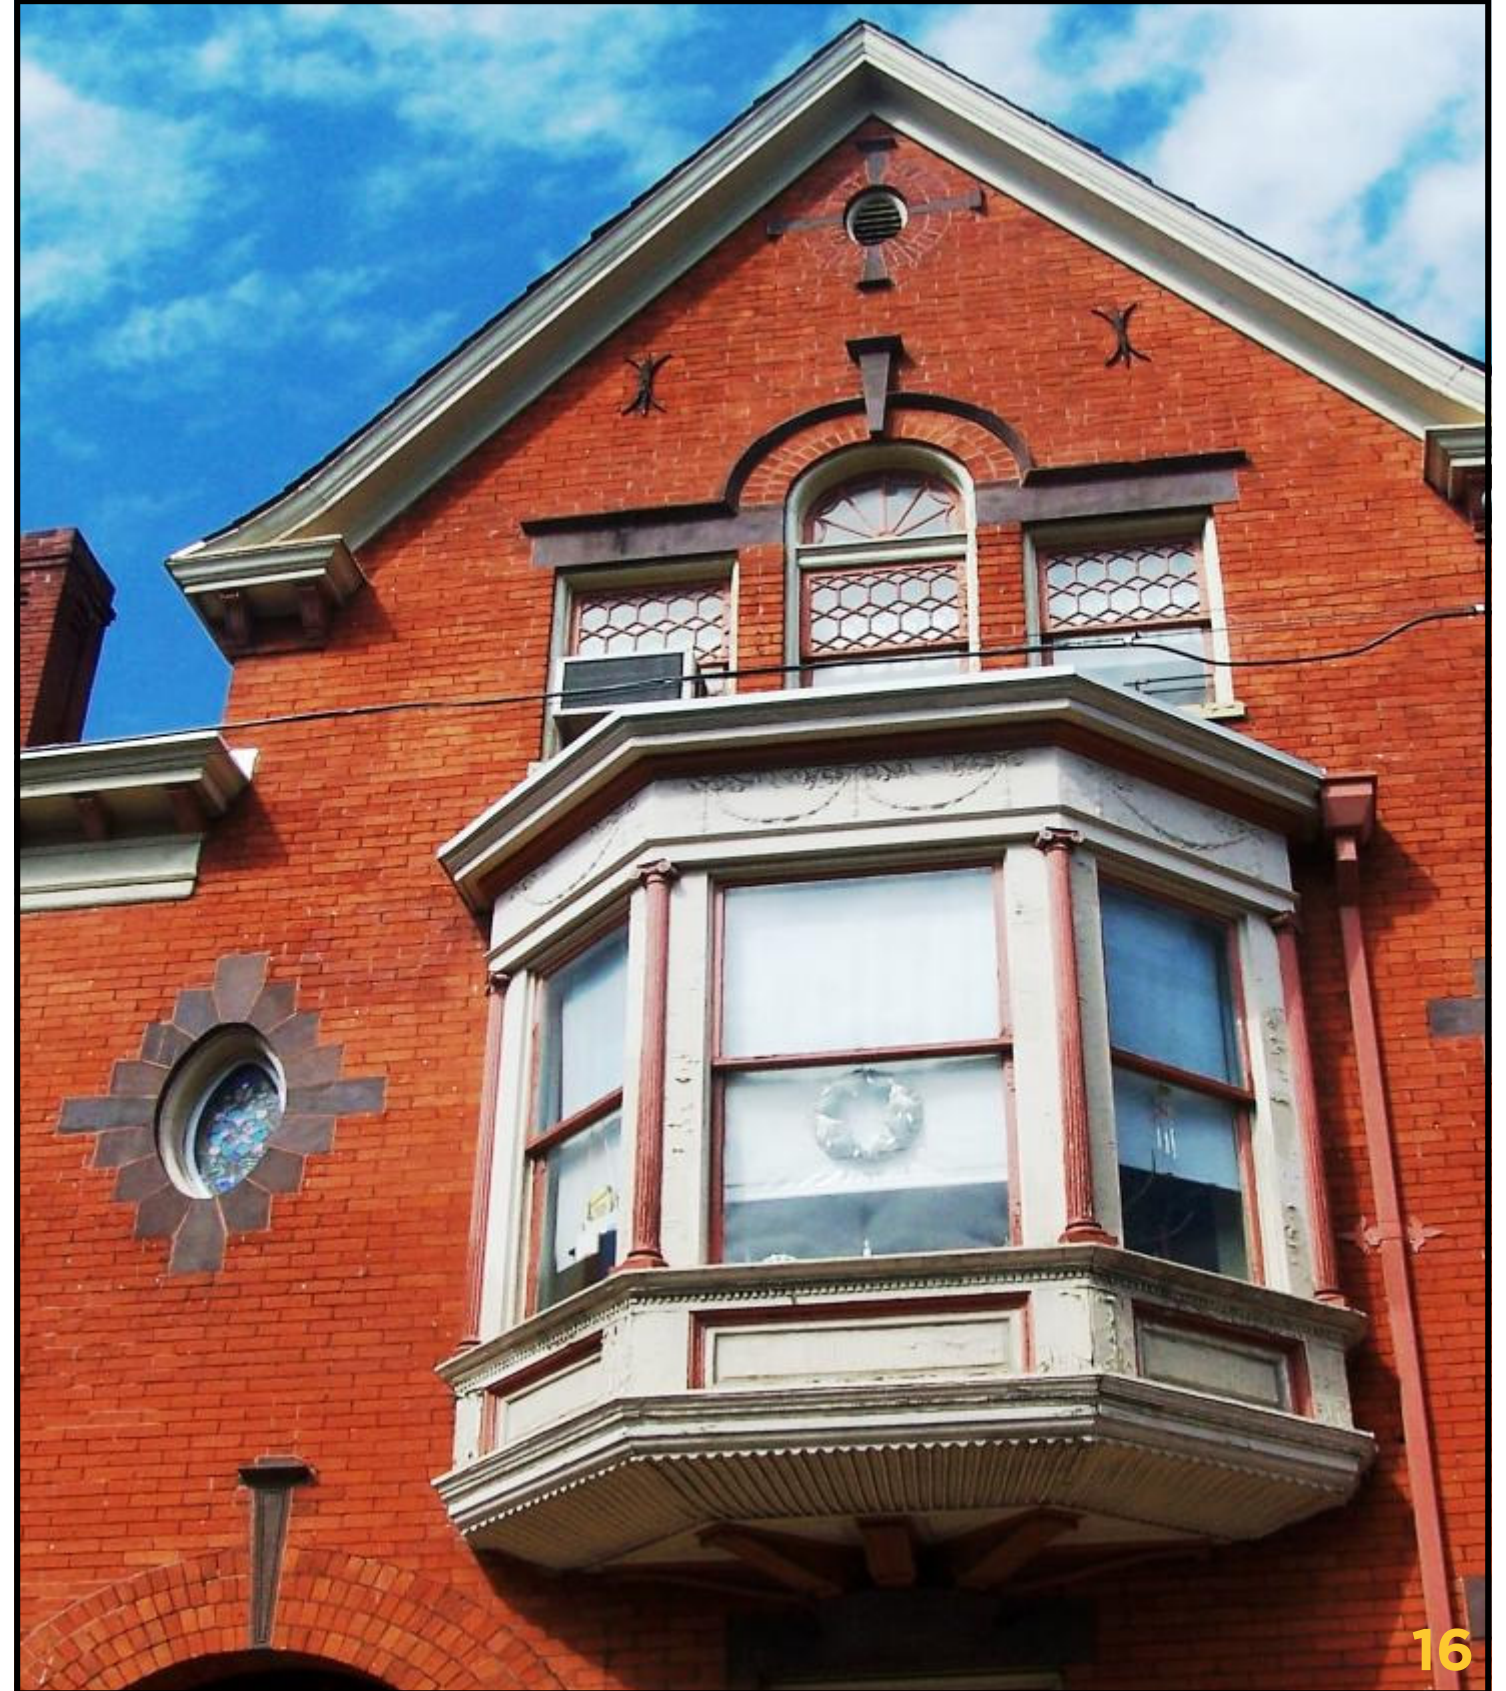
Early 20th century Queen Anne style house  
Original windows help define the character of older buildings
